PA-AWWA 64th Annual Conference

SUSTAINABLE MUNICIPAL INFRASTRUCTURE PLANNING, MAINTENANCE, REPAIR, AND REPLACEMENT IN KARST SINKHOLE PRONE AREAS

***Michael Perlow Jr., P.E. – M. ASCE
Engineering Knowledge Management LLC
443 Main Street – East Greenville, PA 18041
Tel: 267-664-3250 Fax: 267-612-4078
Email: mike@michaelperlowjr.com***

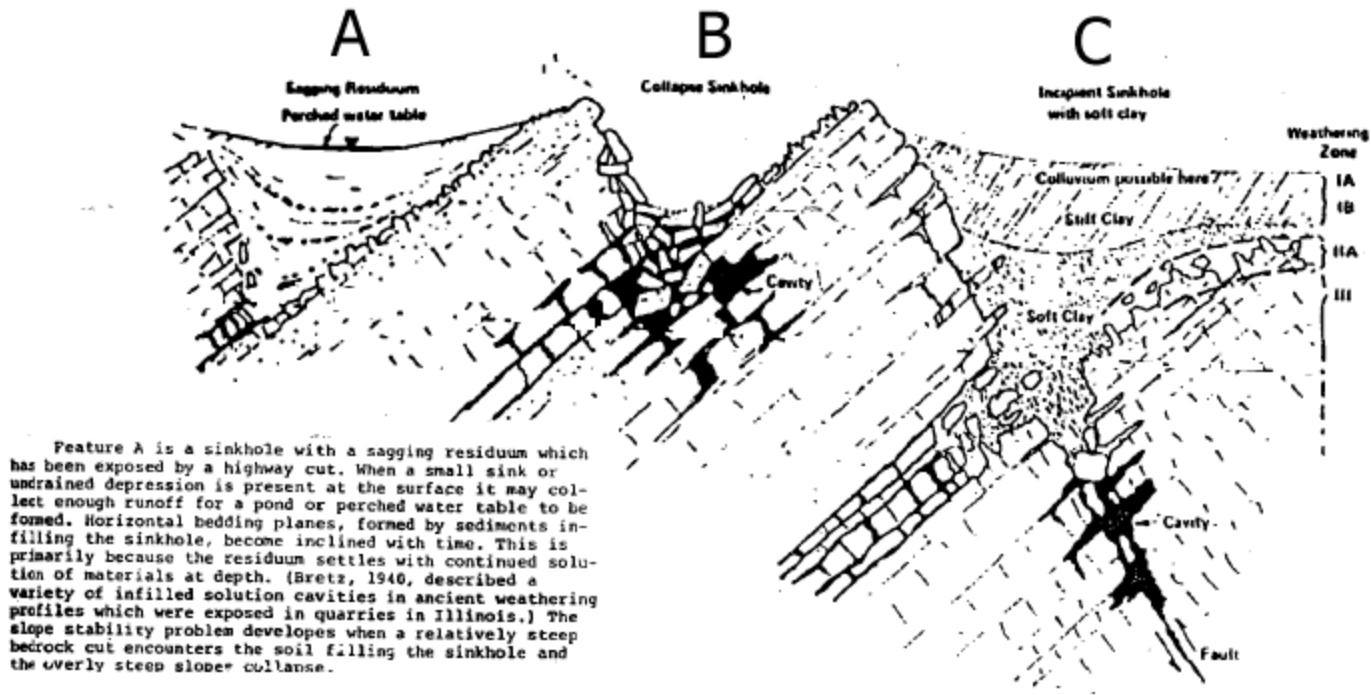
THE PROBLEM – KARST GEOLOGY

Feature A is a sinkhole with a sagging residuum which has been exposed by a highway cut. When a small sink or undrained depression is present at the surface it may collect enough runoff for a pond or perched water table to be formed. Horizontal bedding planes, formed by sediments infilling the sinkhole, become inclined with time. This is primarily because the residuum settles with continued solution of materials at depth. (Bretz, 1940, described a variety of infilled solution cavities in ancient weathering profiles which were exposed in quarries in Illinois.) The slope stability problem develops when a relatively steep bedrock cut encounters the soil filling the sinkhole and the overly steep slope+ collapse.

Feature B, the collapse sinkhole, seldom causes a stability problem. Although the collapsed rock may be weaker than the surrounding rock, the nature of the material is apparent when the excavation begins. However, the collapsed debris may become mixed with clayey residual soil and a larger slope failure could develop.

Feature C is an incipient sinkhole in which the lower portion is filled with soft clay. This feature is likely to lead to a more serious slope failure than the others because the low strength of the soft clay may not be determined until the slide develops.

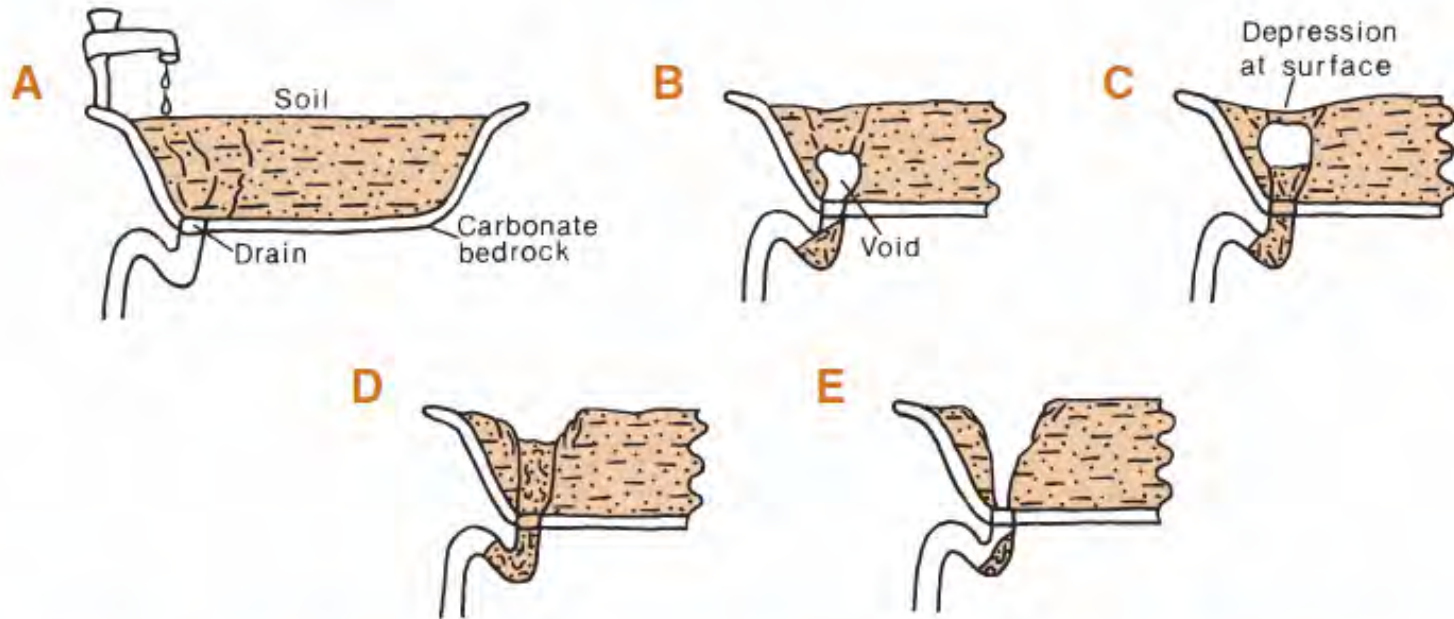
Figure 9. The bathtub model. A. Water infiltrates through the soil. B. As soil enters the drain, a void is left behind. C. Over time, the soil moves into the void and the void “migrates” toward the surface. D. Support is removed and collapse occurs. E. If enough water is supplied, an open connection to the drain results.

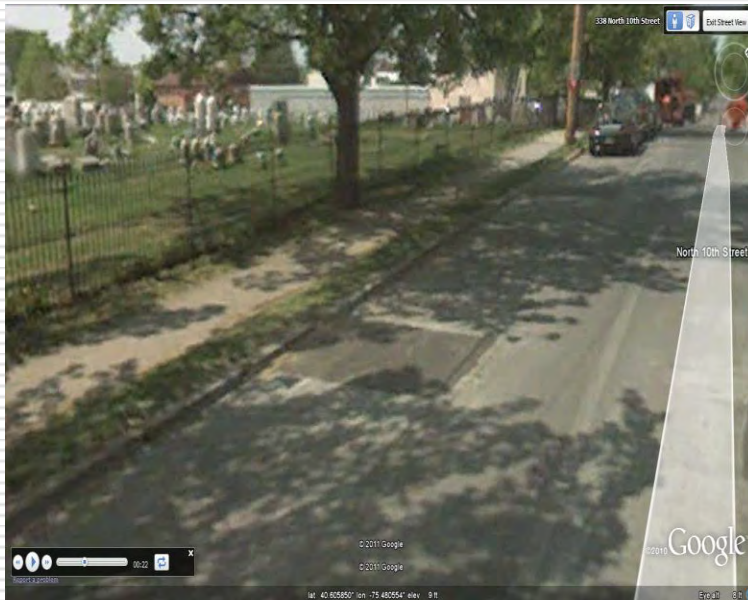
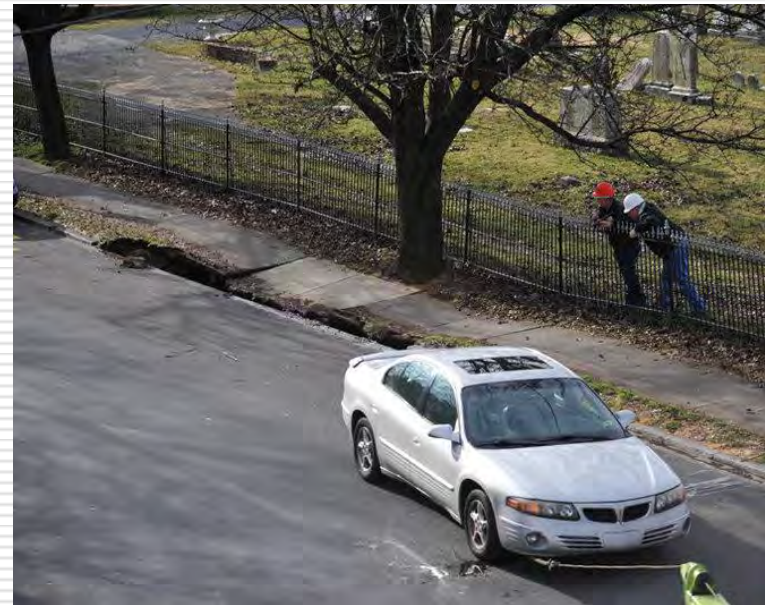
PROBLEM BACKGROUND

- ❑ **Migration of surface water from deteriorating pavements, sidewalks, and curbs into residual soils can result in slow subsurface erosion of soil into the underlying bedrock resulting in subsidence.**

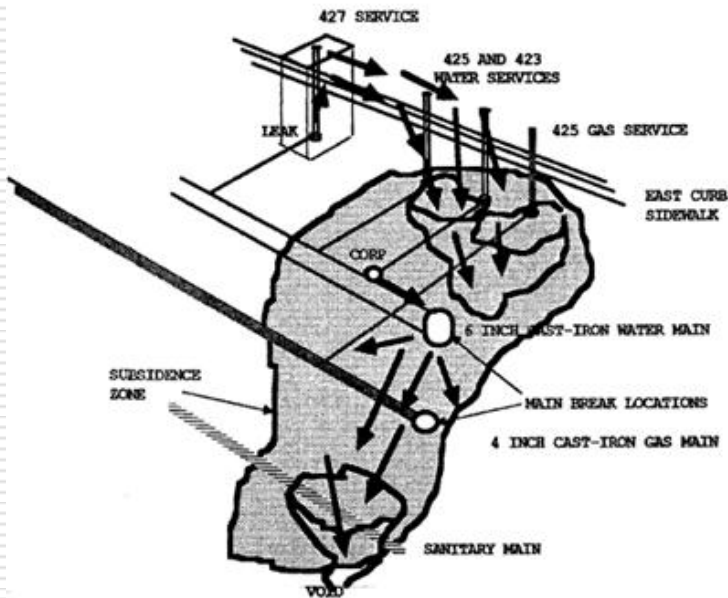
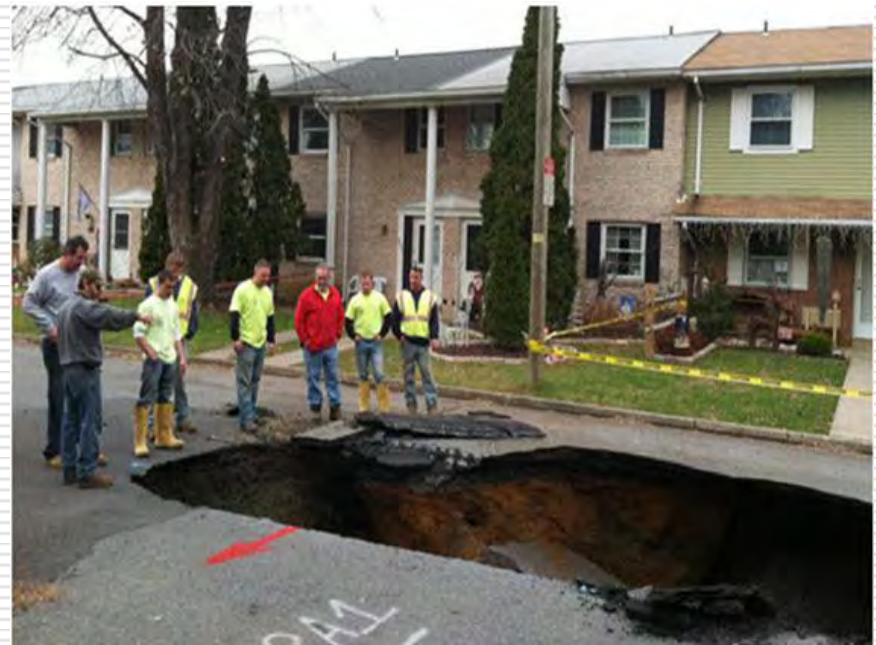
PROBLEM BACKGROUND

- ❑ Subsidence of soil supporting utilities can in turn result in leaks or even main breaks that can result in significant subsurface erosion and the formation of a sinkhole.

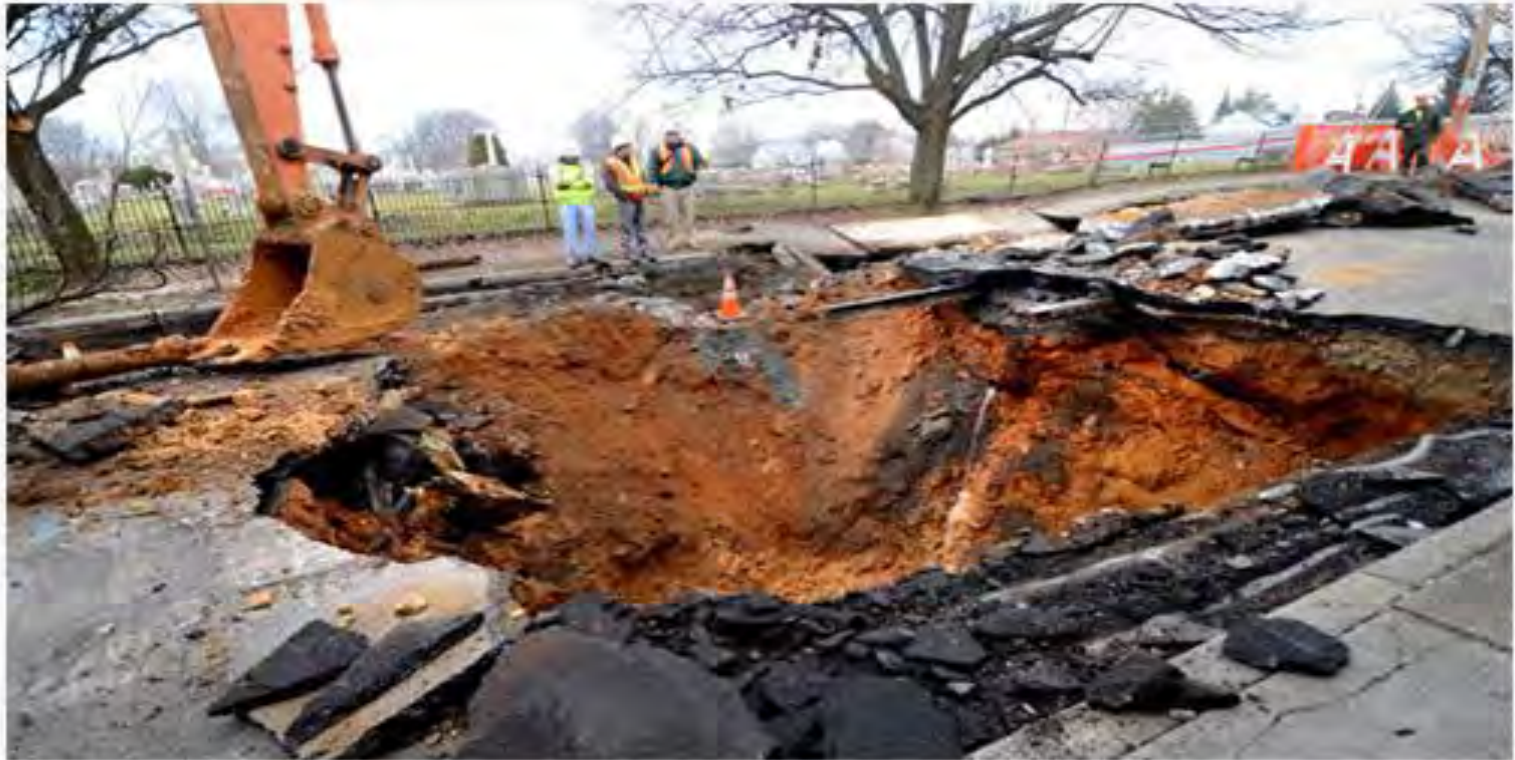
Allentown water main break

Officials gather as the sinkhole at 10th and Gordon Streets undergoes excavation. Old trolley tracks are evident at right.

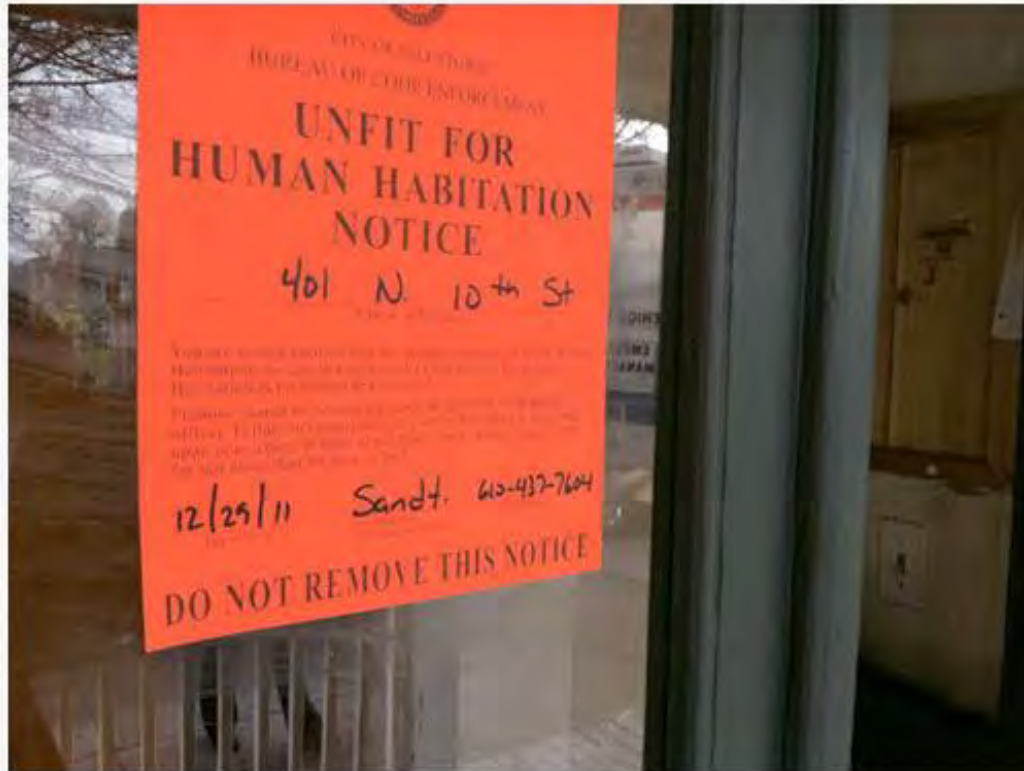
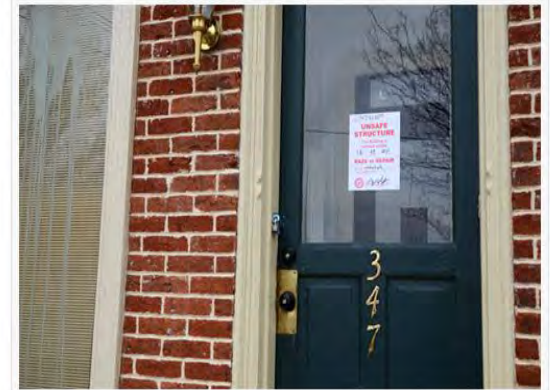
Allentown water main break

A new sign marks the home at 401 N. 10th Street as unfit for habitation in the wake of a water main break in the street's 300 block Thursday morning.

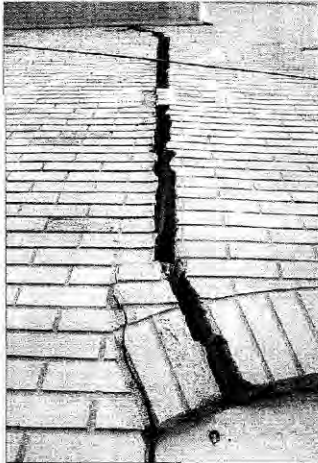
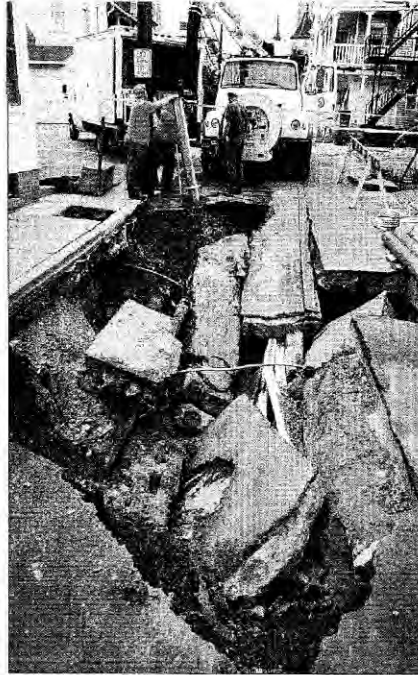
NORTH PENN STREET ALLENTOWN

N. Penn St. in Allentown is cracked after a sinkhole opened up early Tuesday. Right, city Water Resources employees work on the sinkhole. Eleven homes were evacuated about 3 a.m. Residents were allowed to go back later to get their belongings.

A 20-by-10-foot sinkhole opened on an Allentown block Tuesday morning, damaging homes and causing evacuations, fire officials said.

Stalitz said workers found that a century-old water main that the city is replacing had cracked. The old pipe was still in partial use because a handful of properties in the area had not been transferred to the new main, he said.

Stalitz said workers couldn't tell whether the sinkhole caused the pipe to break or vice versa.

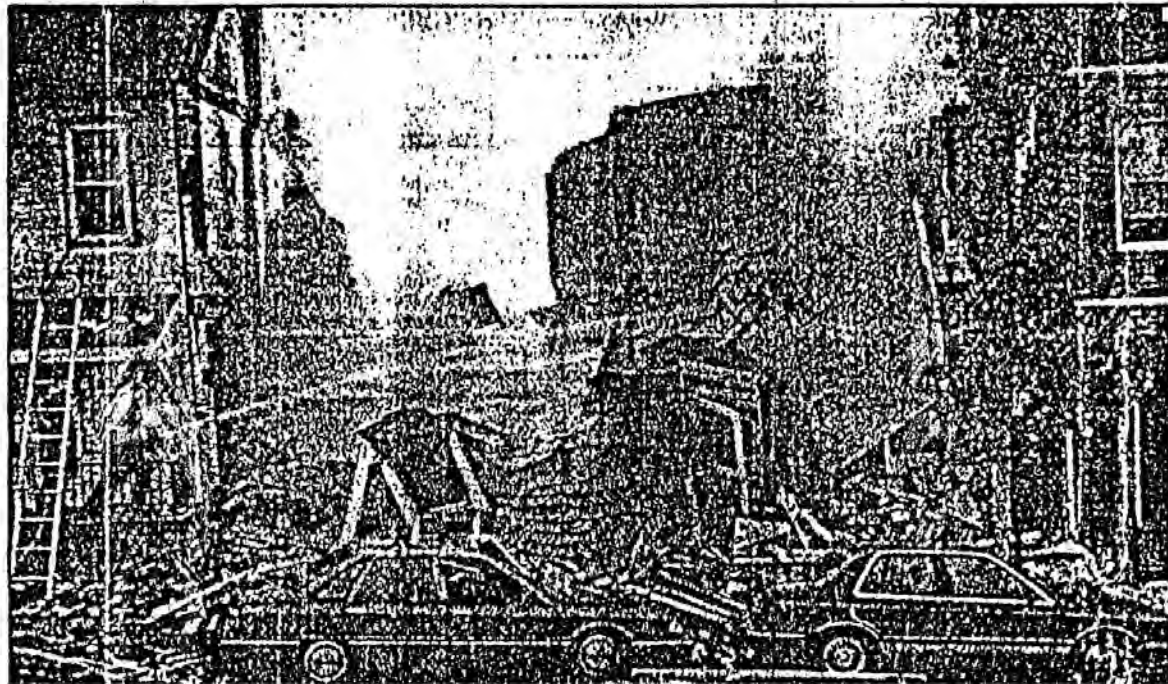
An Allentown fire-fighter hoses down the remains of two homes destroyed in an early morning explosion and fire that killed one person and injured at least seven. The homes are at 423 and 421 N. 5th St.

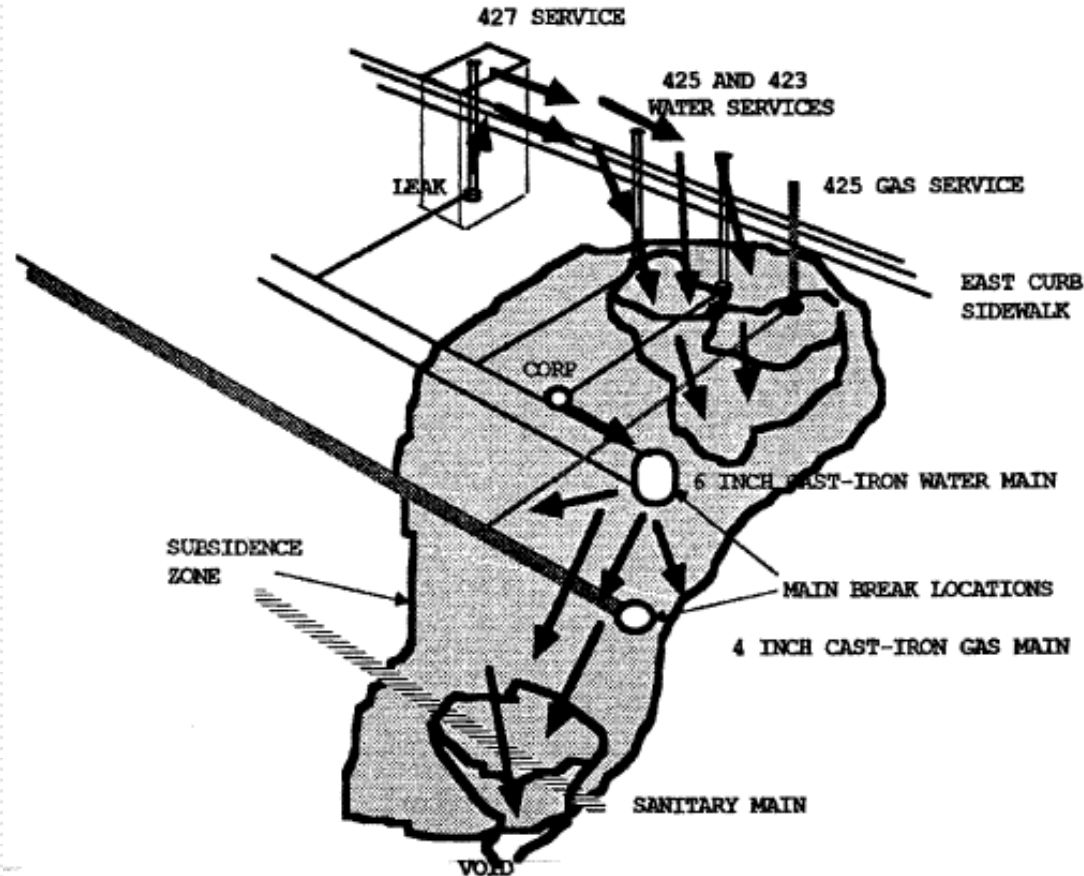
NORTH 5TH STREET - ALLENTOWN

1. HARD/SOFT PAVEMENT SUBGRADE SUPPORT RESULTS IN CRACKING OF CONCRETE PAVEMENT
2. SURFACE WATER BEGINS TO MIGRATE OVER TIME INTO CRACKS SOFTENING RESIDUAL SOILS

3. SLIGHT SUBSIDENCE OCCURS IN SOLUTION ZONES
4. SUBSIDENCE AT LEAD JOINT AT CURB BOX/CORP RESULTS IN LEAK/BREAK OF WATER SERVICES OVER THE PAST 35 YEARS WHICH FURTHER DESTABILIZE SUPPORTING SOILS IN PINNACLED ROCK AREAS

5. WATER SERVICE LEAK OCCURS AT 427 ON 1/28/90 MIGRATING WATER FOLLOWS SIDEWALK/CURB
6. RELEASED WATER ENTERS BEDROCK SOLUTION ZONE RESULTING IN SUBSIDENCE OF SUPPORTING SOILS FOR 425 & 423 GAS/WATER LATERALS

7. FURTHER LEAKS OCCUR IN 423 LATERALS ON 8/29 RESULTING IN A MAJOR LEAK OF GAS AND WATER
8. GAS EXPLOSION OCCURS BREAKING LATERALS/MAIN
9. ONCE WATER MAIN BREAKS, SUBSURFACE EROSION OF SUPPORTING SOILS OCCURS BY ENTRY OF RELEASED WATER INTO UNDERLYING SOIL AND ROCK VOIDS

10. SANITARY MAIN SUBSIDES/GAS MAIN IS BROKEN
11. SUBSURFACE EROSION CONTINUES UNTIL MAIN IS SHUT OFF RESULTING IN MAJOR GROUND LOSS AND SUBSIDENCE

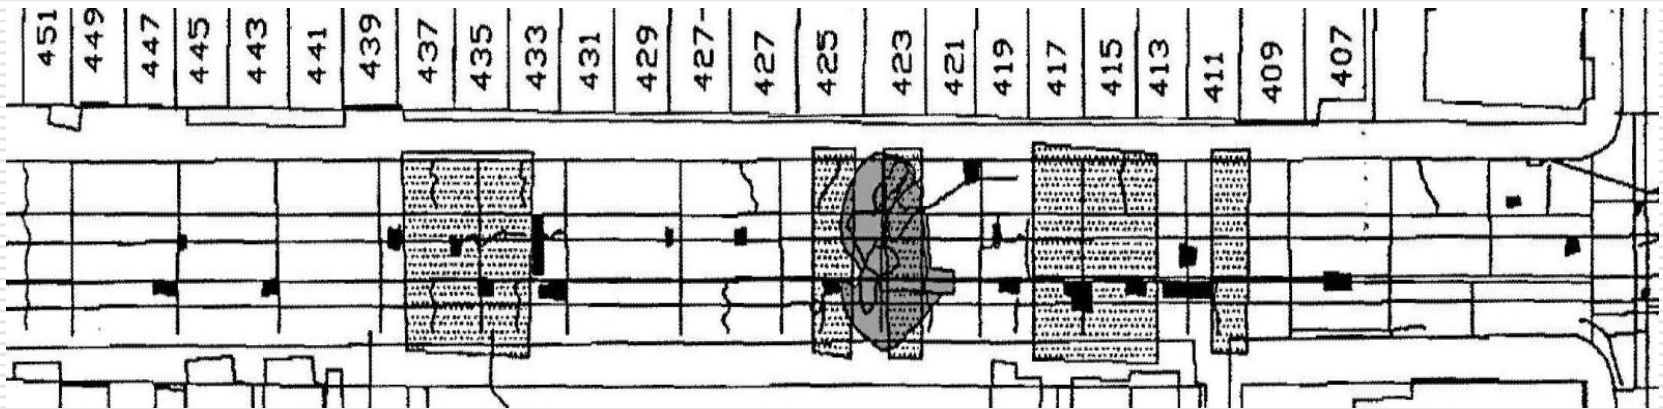
- Pavement cracking was an early indicator of subsurface erosion and subsidence
- The increasing number of water service leak-break frequency was a secondary warning
- The presence of suspected solution weathering zones identified where a failure could occur
