**PENNSYLVANIA
AMERICAN WATER**

Improving Pump Efficiency to Decrease Energy Consumption

**Ralph Wawrzyniakowski, EIT
Pennsylvania American Water**

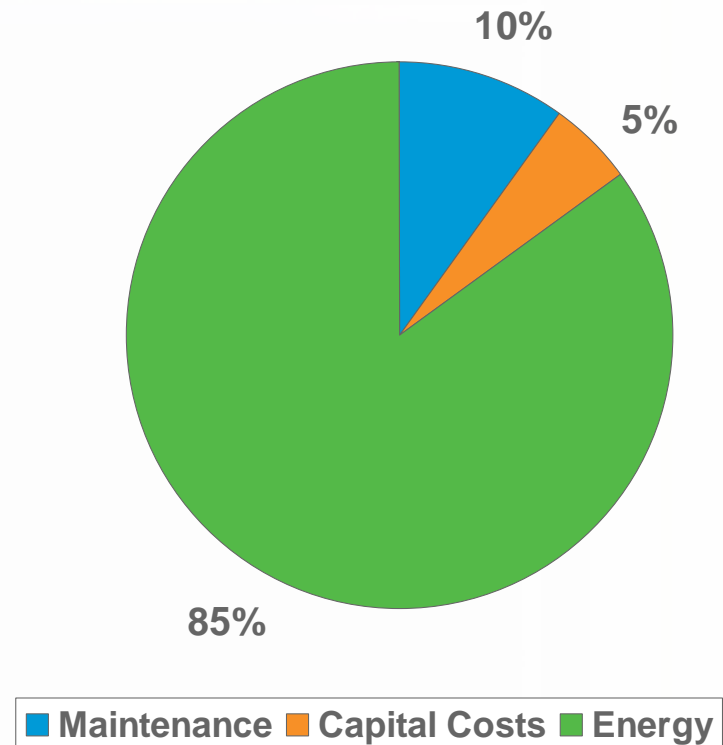
- Typical bowl efficiency of new, high efficiency pumps: 83-88%
- Typical wire-to-water efficiency (assuming 95% motor efficiency): 79-84%
- The capital cost of a pump installation is a small percentage of the Life Cycle Cost (LCC)
 - **Energy: 85%**
 - Maintenance: 10%
 - Capital cost: 5%

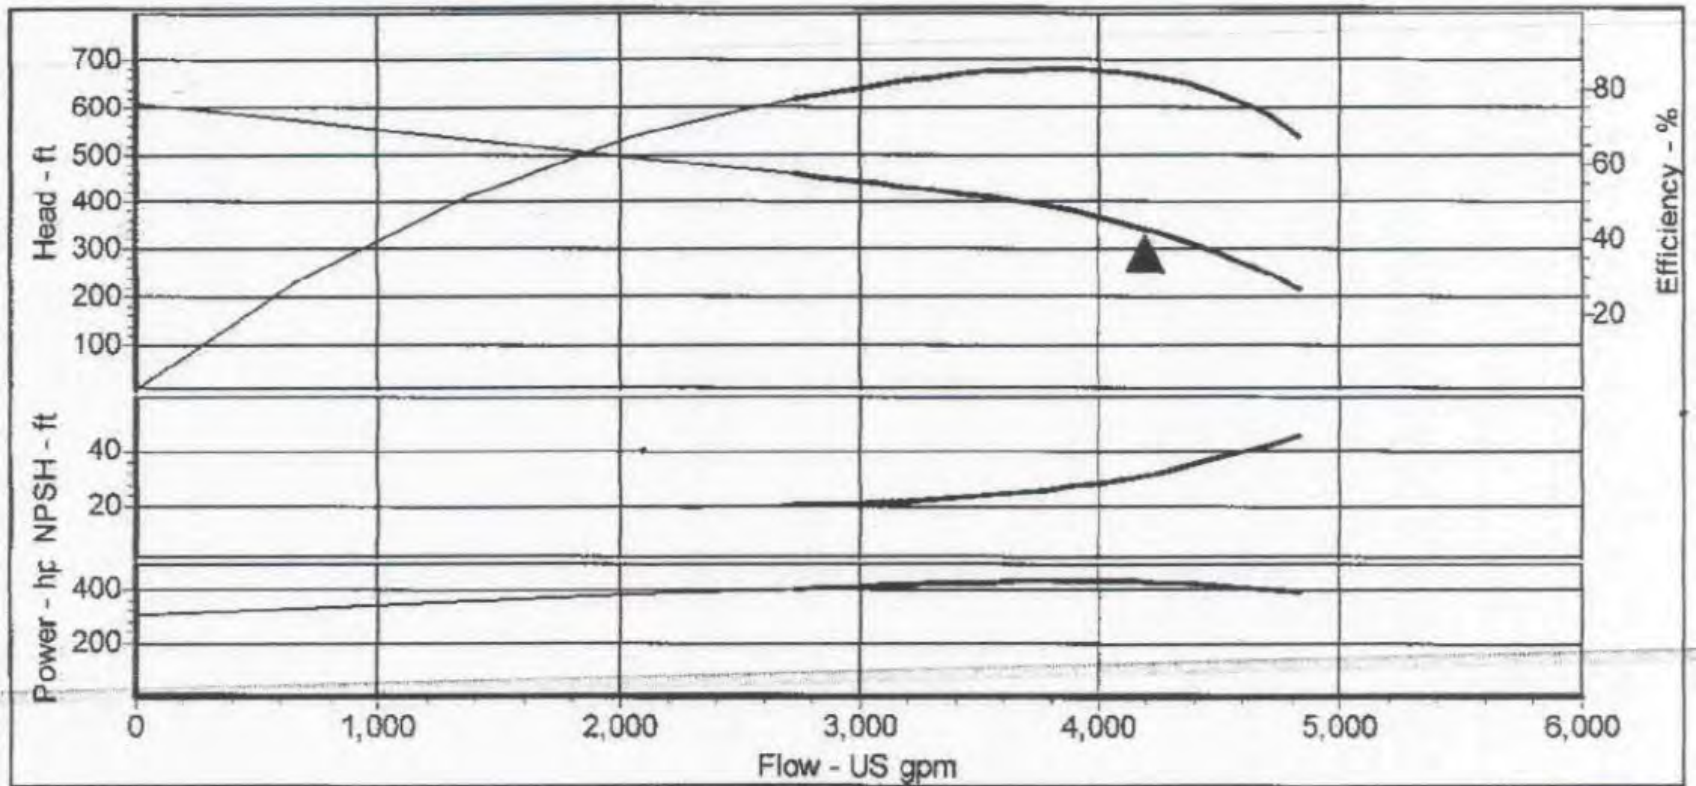
- **Listen**
 - Cavitation (cracking sound)
 - Vibration
- **Look**
 - Excessive leaking (seals)
- **Vibration Analysis**
 - Accelerometers mounted to pump; software is used to compare to baseline (new pump) data
- **Thermography (Infrared Scanning)**
 - For early detection of 'hot spots' – deteriorating motor windings, hot running bearings, etc.
- **Evaluate Current Pump Curve**
 - Created from wire-to-water
 - Compare to new/factory pump curve

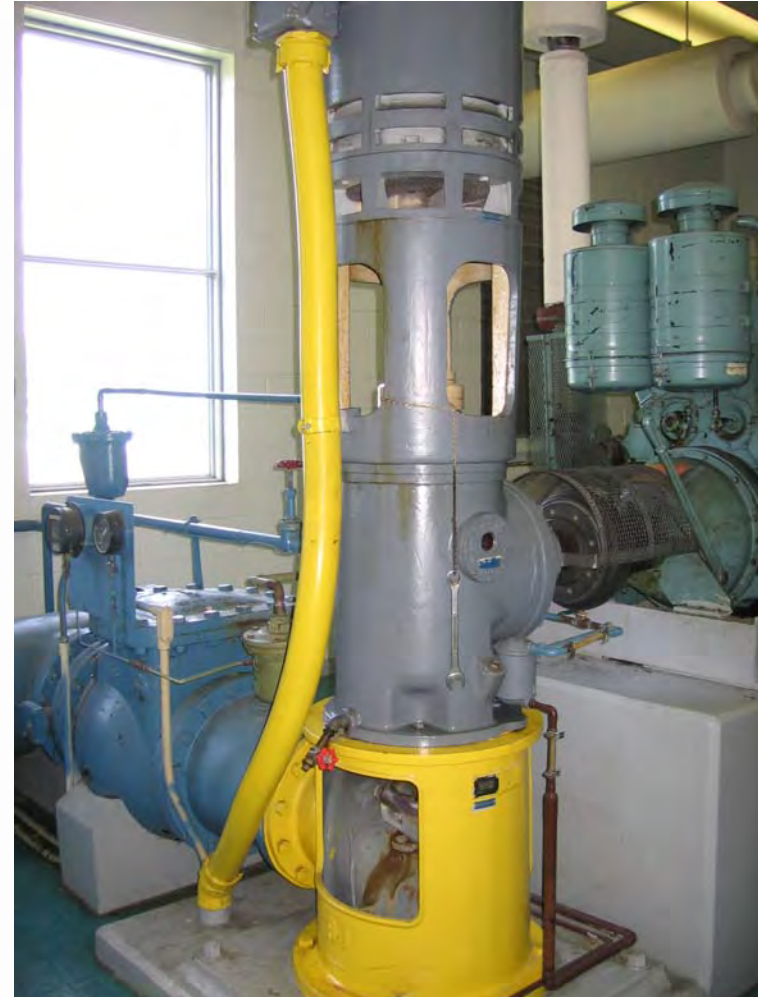
- **Original wire-to-water efficiencies**
 - #1: 74%
 - #2: 70%
 - #3: 67%
- **Findings**
 - TDH/Flow requirements changed
 - Pumps were not operating efficiently on factory curve
 - VSD was needed to maintain adequate service to customers efficiently

- **Pumps replaced**
 - Replace pumps with correctly-sized pumps
 - Replace motors with premium efficiency 150 hp motors
 - Add electrical VSDs to 2 of 3 pumps
- **Current wire-to-water efficiencies**
 - #1: 80%
 - #2: 80%
 - #3: 81%
 - Original wire-to-water efficiencies – 67%-74%
- **Pumps designed at 2150 gpm, 215 ft, 84% efficiency**
- **Now properly sized – operating more efficiently**

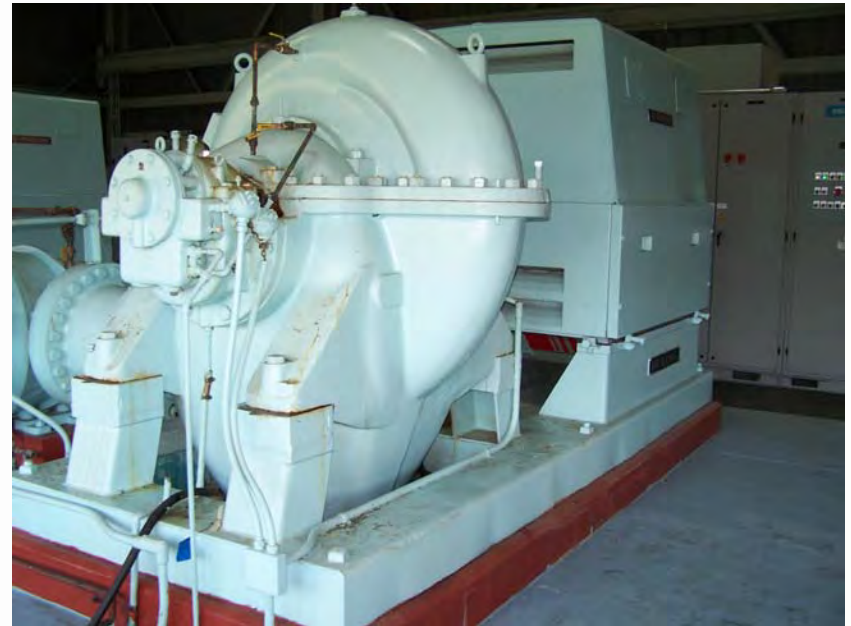
- **Relay pump station**
 - 35 MGD ADD
- **Five relay pumps (>95% of location energy usage)**
 - Vintage pumps and motors (1960s)
 - Three 10 MGD pumps
 - Two 20 MGD pumps
- **10 MGD Pumps designed at 7000 gpm, 360 ft, 87% efficiency**

- **Original Wire-to-Water Efficiencies (10 MGD)**
 - #1: 65%
 - #2: 65%
 - #3: 63%
- **Findings**
 - Normal pump wear reduced efficiencies
 - Pumps were not operating efficiently on factory curve
 - Pumps designed correctly for application

- **2012-2014 pumping refurbishment projects**
 - Refurbish pumps
 - Replace motors with premium efficiency motors
 - Project ongoing from 2012-2014
- **Current wire-to-water efficiency**
 - #3: 85%
- **Pumps designed at 7000 gpm, 360 ft, 87% efficiency**
- **Pumps now running more efficiently and effectively**

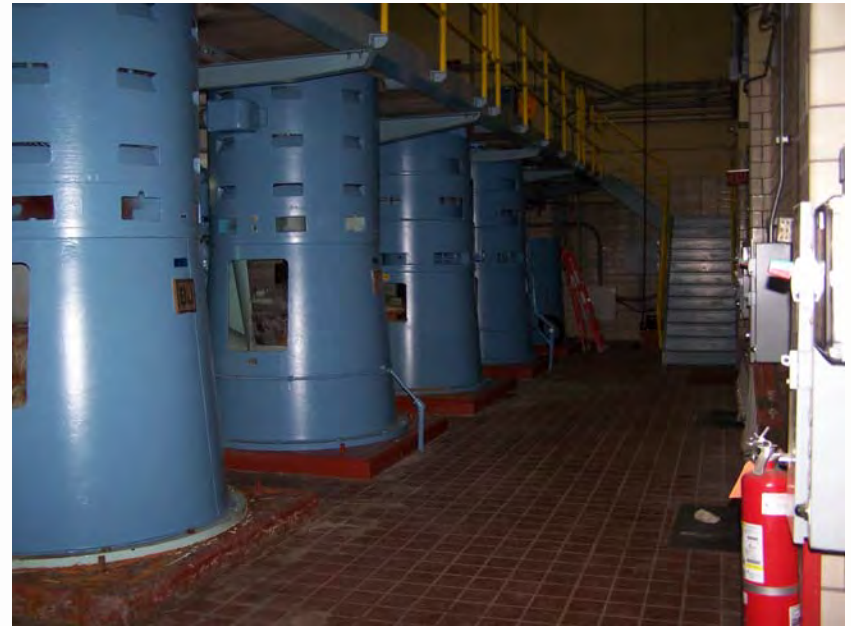
- **Treatment Plant**
 - 50 MGD Plant Capacity
 - 35 MGD ADD
- **5 Potable Water Pumps (90%+ of location energy usage)**
 - Vintage pumps and motors (1960s)
 - Three, 10 MGD pumps
 - Two, 20 MGD pumps
- **10 MGD Pumps designed at 7000 gpm, 420 ft, 87% efficiency**

- **Original Wire-to-Water Efficiencies (10 MGD)**
 - #1: 70%
 - #2: 59%
 - #3: 77%
- **Findings**
 - Normal pump wear reduced efficiencies
 - Pumps were not operating efficiently on factory curve
 - Pumps designed correctly for application
 - Refurbishment of pumps would cost more than replacement

- **2012-2014 pumping replacement projects**
 - Replace pumps
 - Replace motors with premium efficiency motors
 - Project ongoing from 2012-2014
- **Current wire-to-water efficiency**
 - #3: 83%
- **Pumps designed at 7000 gpm, 420 ft, 85% efficiency**
- **Pumps now running more efficiently and effectively**
