# Manganese Removal in the Poconos – A Success Story

Hemlock Farms Community Association

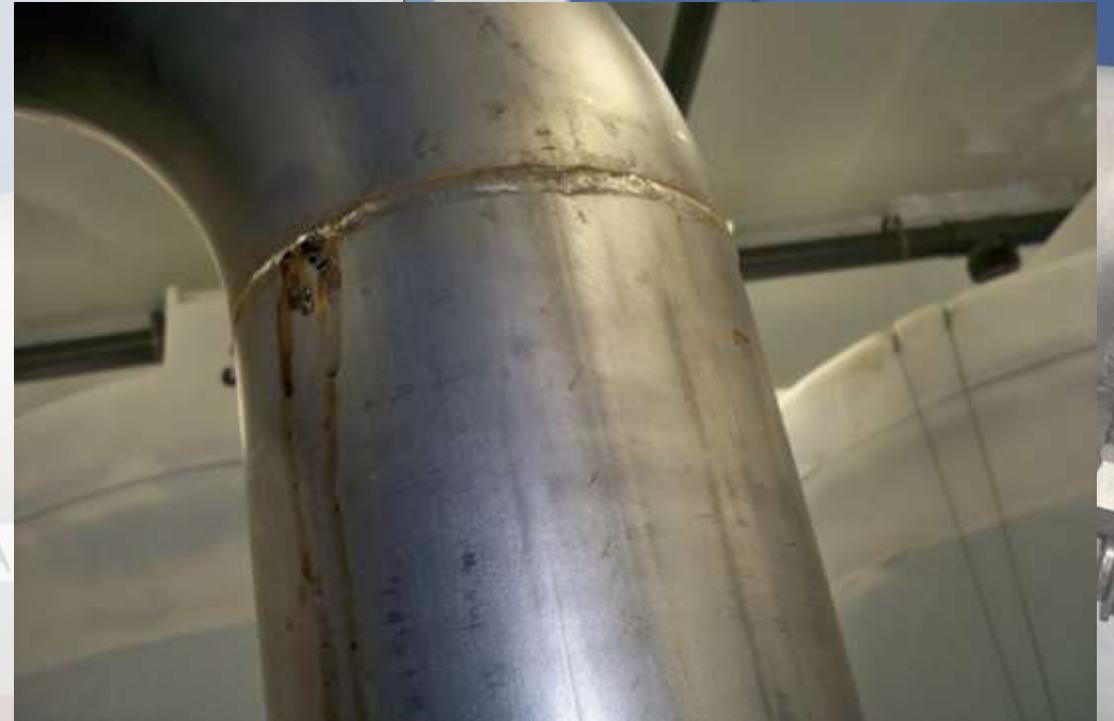
# Stainless Steel Piping Leaks

- Within a year after start-up, leaks appeared at welds in some of the stainless steel piping.
- Review of the piping and literature revealed the cause could be faulty welds, chlorine or microbial induced corrosion.
- Chlorine dose was minimized for oxidation of manganese and then boosted for disinfection to minimize impacts on piping.

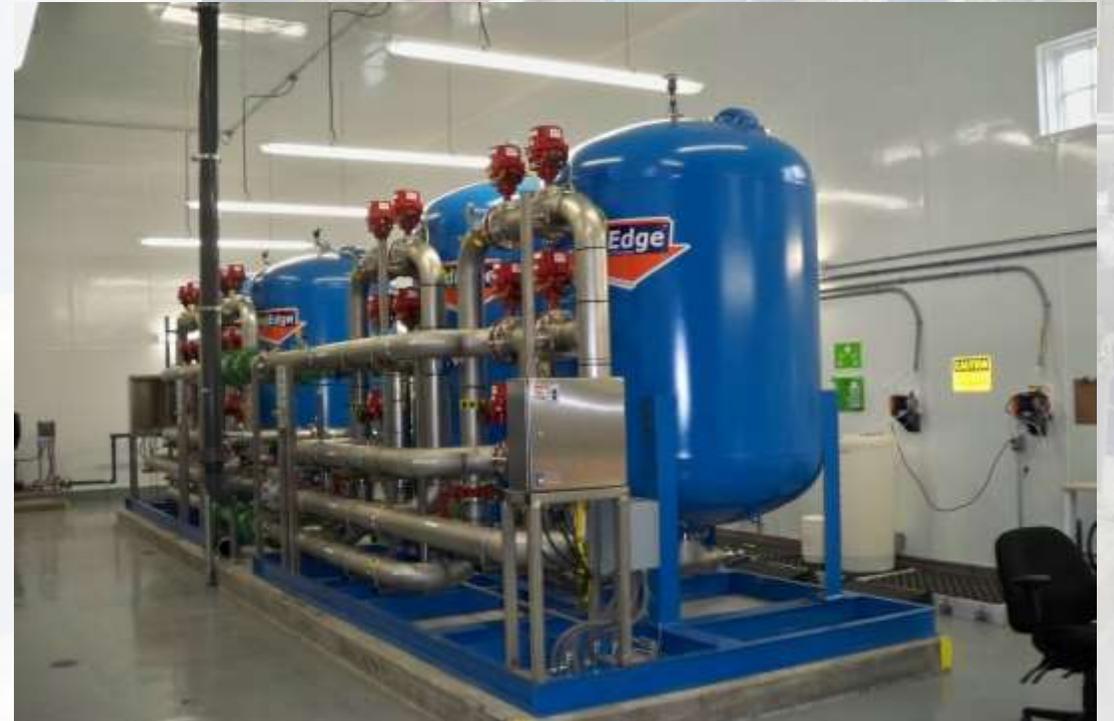
# Piping Resolution

- AdEdge Technologies replaced the portions of the faulty piping.
- A cost sharing approach was implemented by AdEdge and Hemlock Farms to replace the balance of the stainless steel piping.

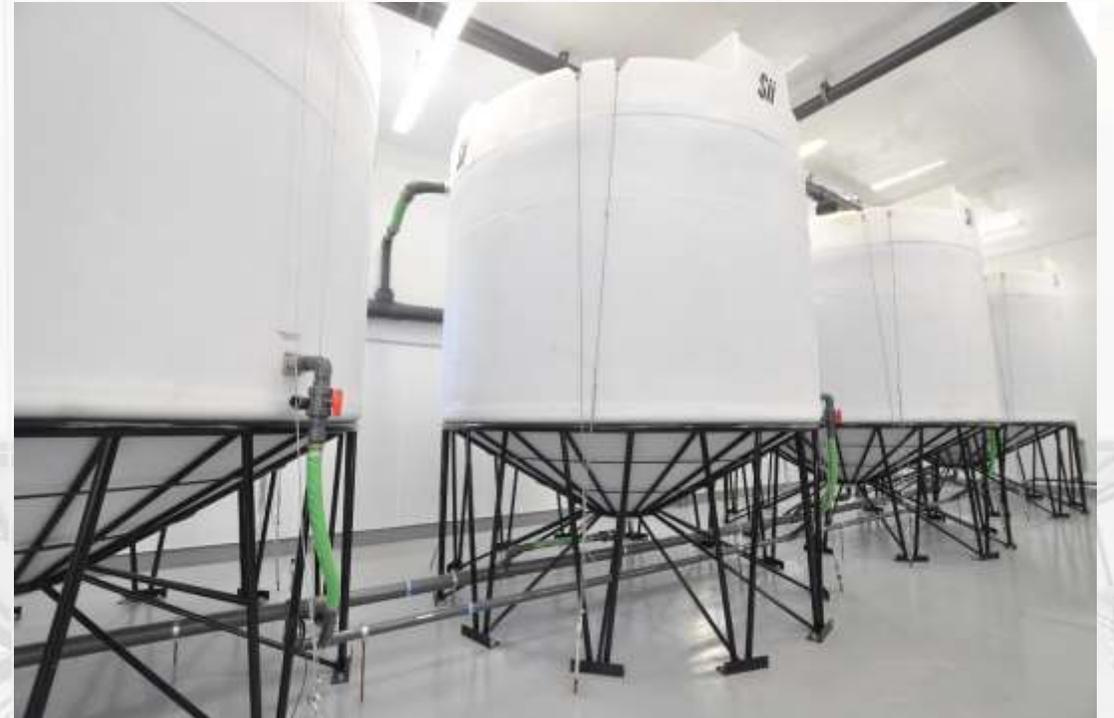
# Residuals Management

- Backwash wastewater is collected in tanks; supernatant is recycled back through the process.
- Manganese sludge is transferred to a yard tank for pumping and hauling to a POTW. Sludge disposal for a year of treatment was less than \$2000.
- Solids separation is excellent. The manganese drops like a rock.
