Locating the Lead in Pittsburgh

PWSA's Strategy to Find and Replace Lead Service Lines

Sarah Bolenbaugh, P.E., Mott MacDonald
Will Pickering, Pittsburgh Water and Sewer Authority

Pittsburgh Water and Sewer Authority, Pittsburgh, PA

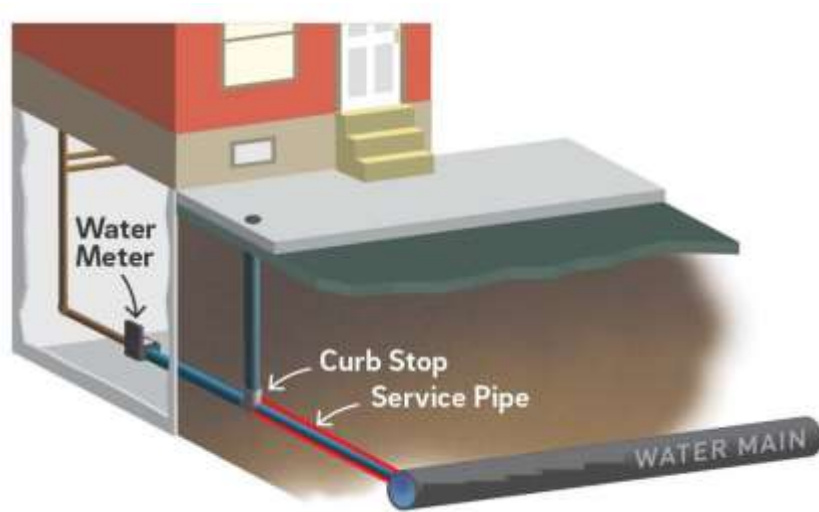
Service Line Ownership

- PWSA Owned – Main to Curb Stop
 - Residential Service: 1” Diameter and Less
 - Single Unit
- Property Owner Responsibility
 - Curb Box to Property – Residential
 - Entire line – Commercial, Multi-Unit Residential

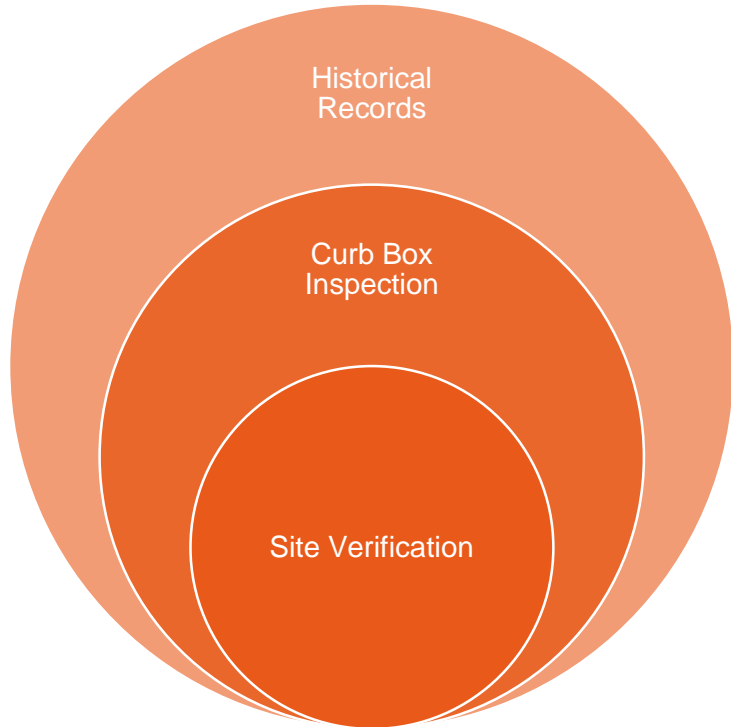
Service Line Material Identification

Historical Record	Service Record	Curb Box Inspection	Reported Material	Action
Lead	None	Lead	Lead	Replace
Lead	None	Unknown	Possible Lead	Verify
Lead	Repair	NonLead	Possible Lead	Verify
No Data	None	Lead	Lead	Replace
No Data	None	Nonlead	Likely Nonlead	Verify (2018)
No Data	None	Unknown	Unknown	Verify

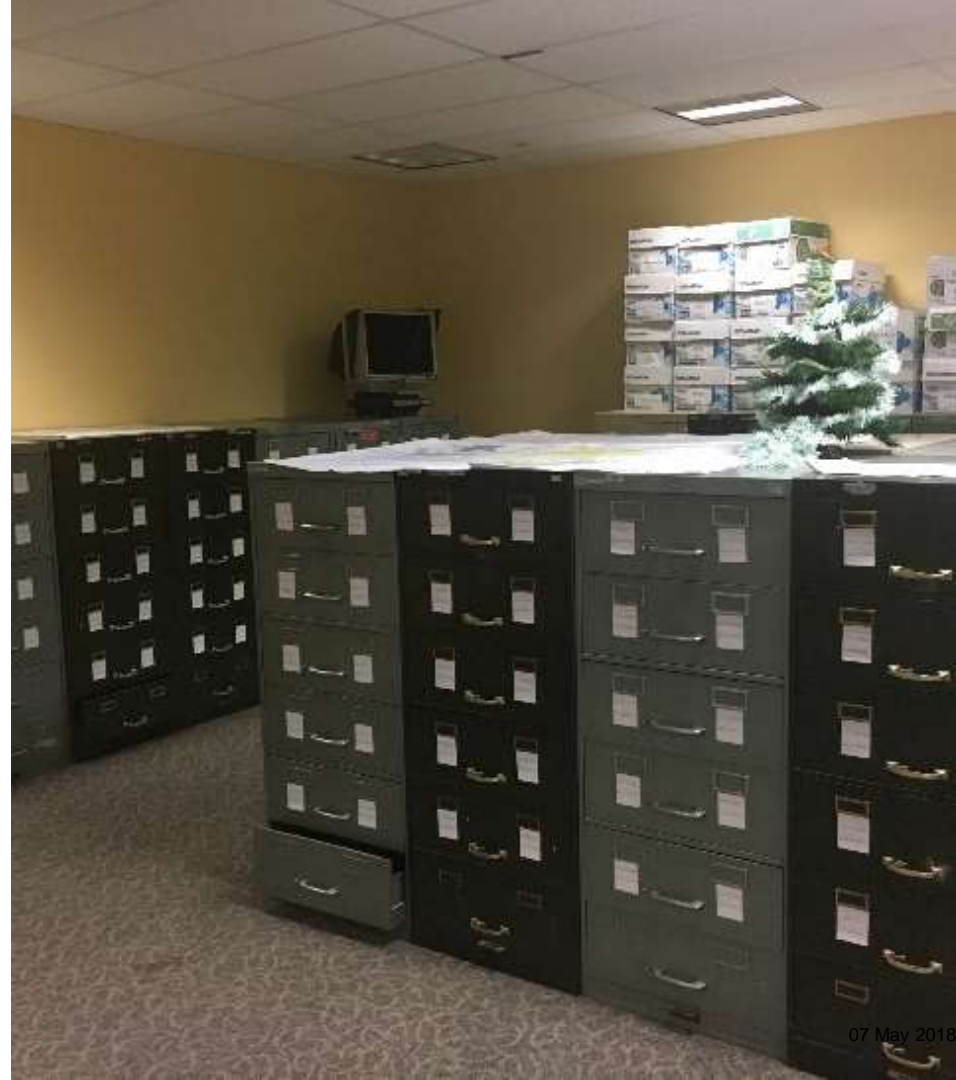
Historical Record Digitization

- Over 120,000 records
- Each Record Contains 1 to 8 half size (4"x5.5") Sheets
- Labor Intensive Data Entry and QA/QC
- Public Side Complete December 2017
- Private Side Complete May 2018
- \$13/Record

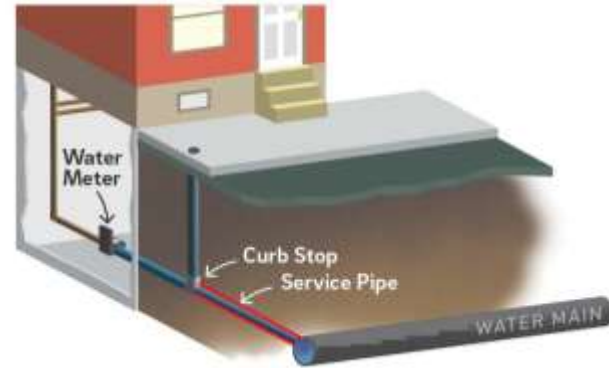
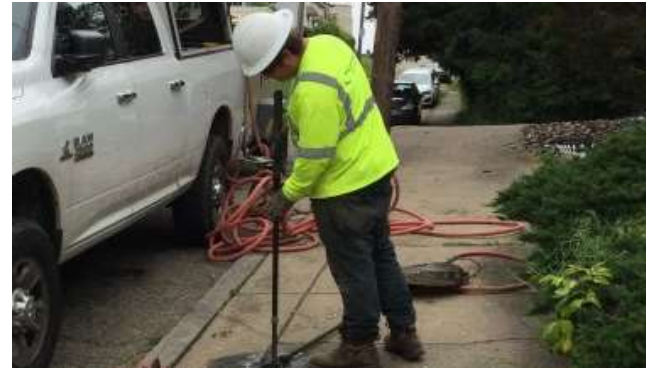
Curb Box Inspection

- Camera Inserted Down Curb Box
- 200-400 Inspections/Work Order
- Work Orders rotates around city
- Positive Identification for lead
- Not all materials can be determined
- Snap-shot of material Curb Box
- Relatively non-invasive

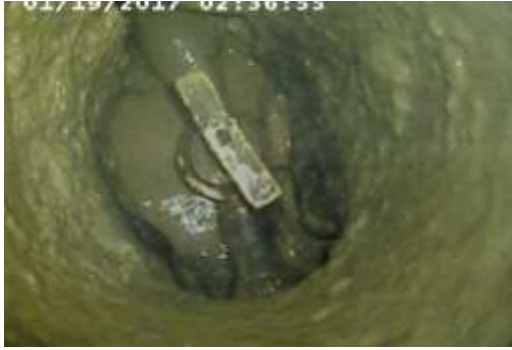
Lead Service Line

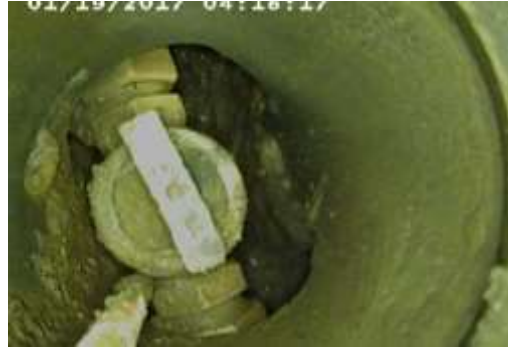
Non-Lead Service Line

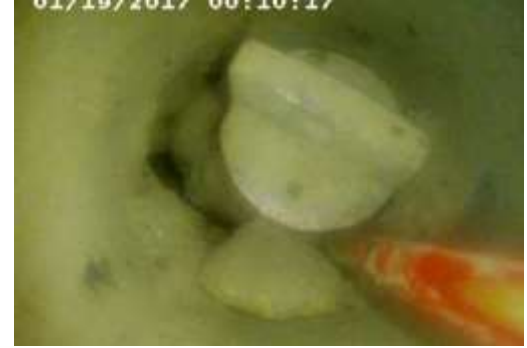
Unable to Determine

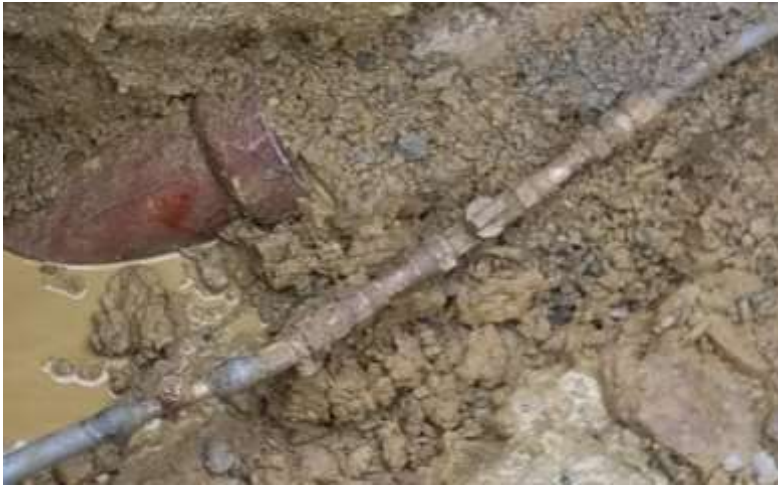
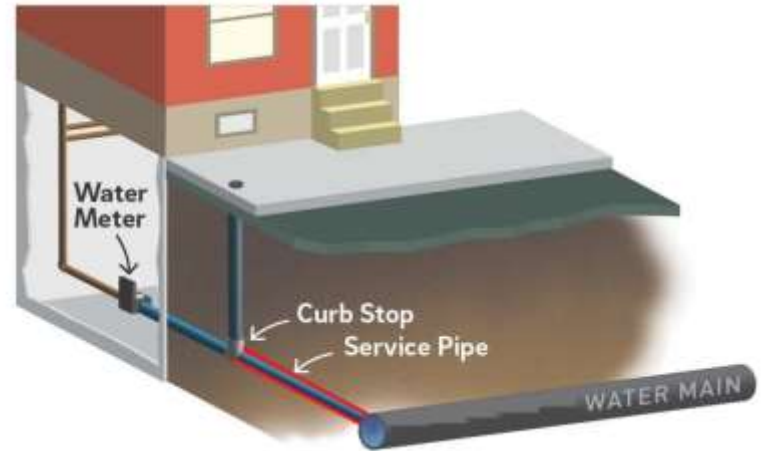
Curb Box Inspection Pitfalls

When the Curb Stop was Replaced

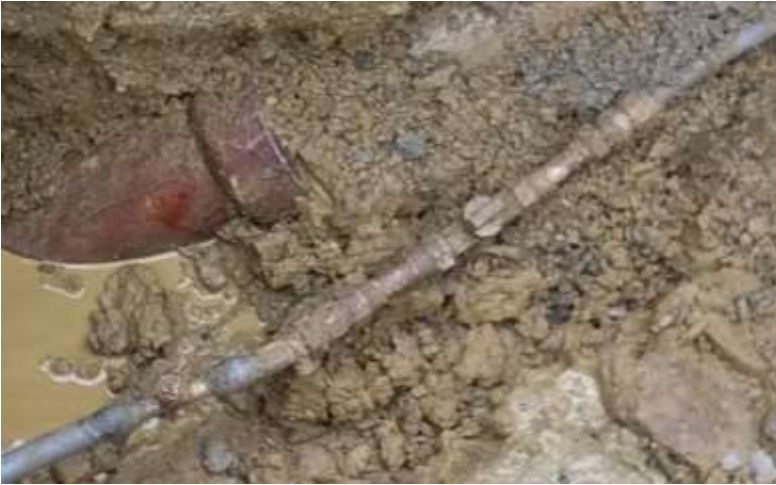
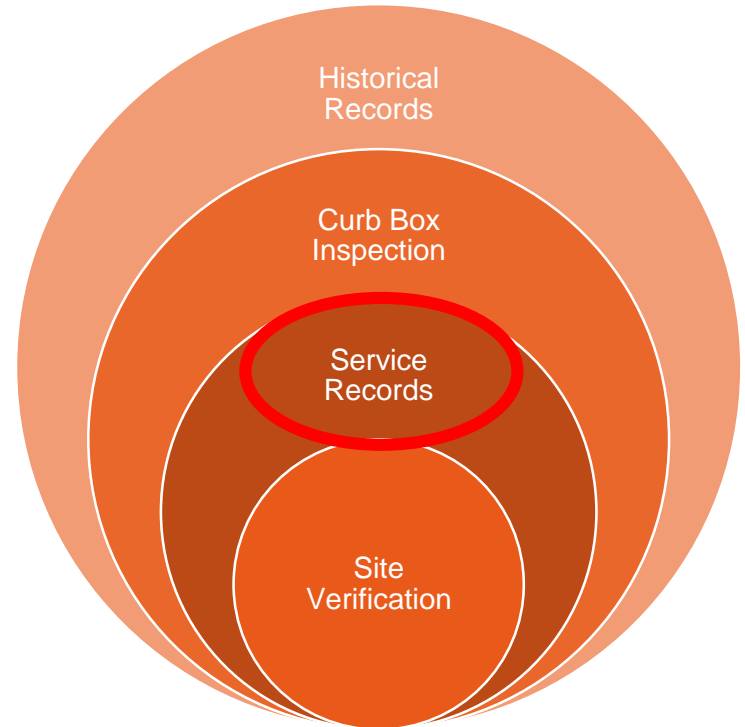
Curb Box Inspection Pitfalls

When the Curb Stop was Replaced

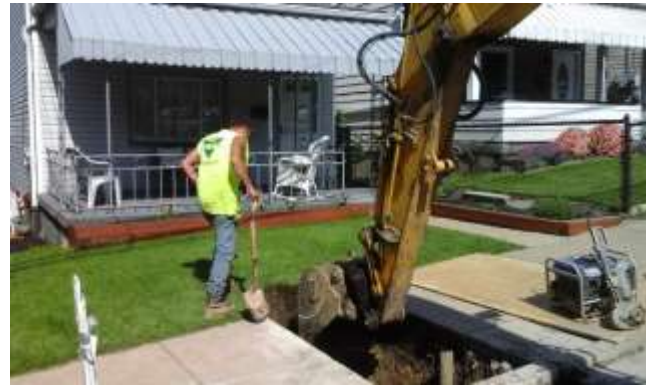
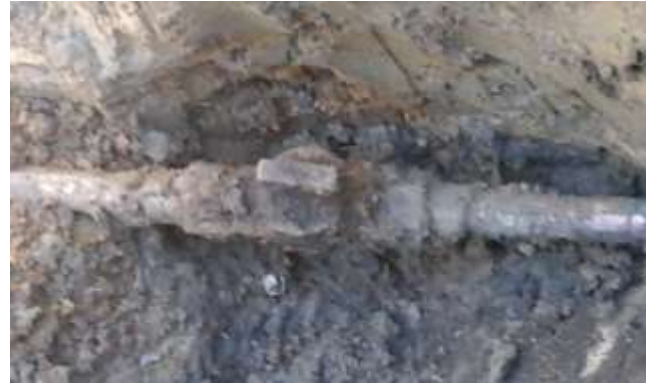
Site Verification (Excavation)

- Dig Test Hole to Confirm Material Type
- More Conclusive than CBI
- Disruptive to Traffic
- Restoration Costs
- Could Temporarily Increase Lead in Water
- Replace if Lead is Found

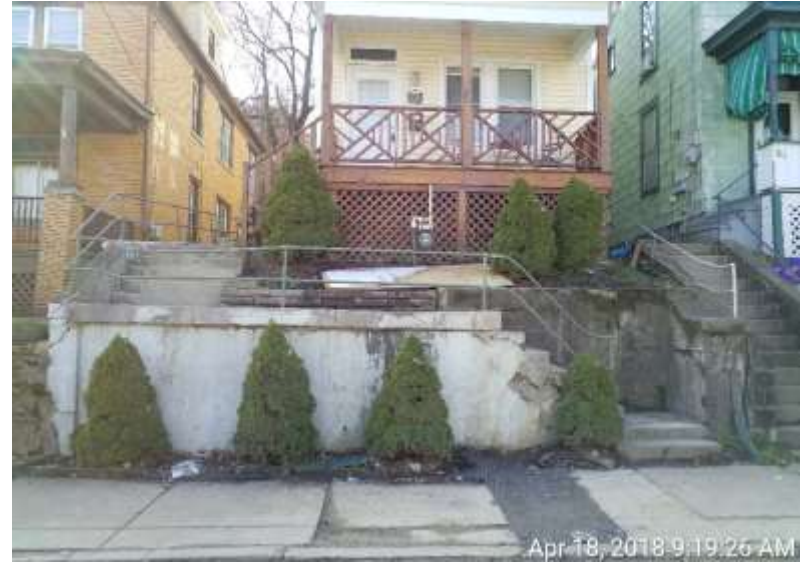
Private Side Lead Service Line Replacement

- 45-Day Notice for Partial Replacement
- Agreement
- No Restoration
- Trenchless
- Inspection

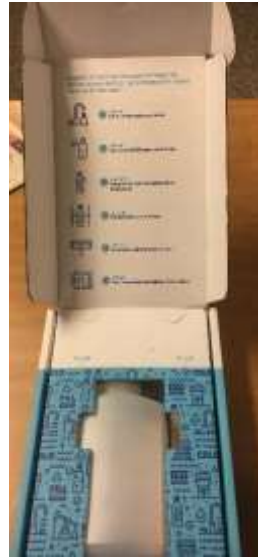
72-Hour Post Construction Water Sample for Partial Replacements

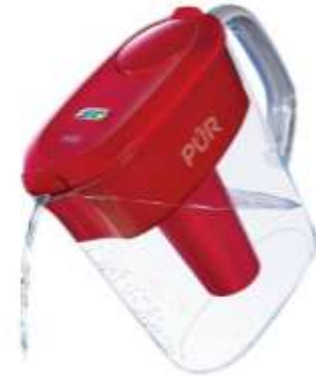
Water Pitcher Filter with Replacement Cartridges for Partial Replacements
