PA-AWWA 64th Annual Conference

SUSTAINABLE MUNICIPAL INFRASTRUCTURE PLANNING, MAINTENANCE, REPAIR, AND REPLACEMENT IN KARST SINKHOLE PRONE AREAS

***Michael Perlow Jr., P.E. – M. ASCE
Engineering Knowledge Management LLC
443 Main Street – East Greenville, PA 18041
Tel: 267-664-3250 Fax: 267-612-4078
Email: mike@michaelperlowjr.com***

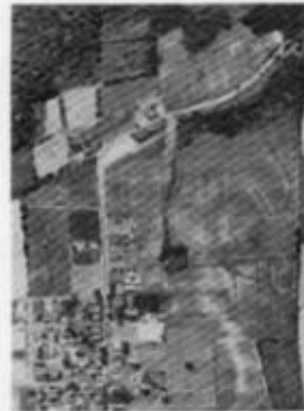
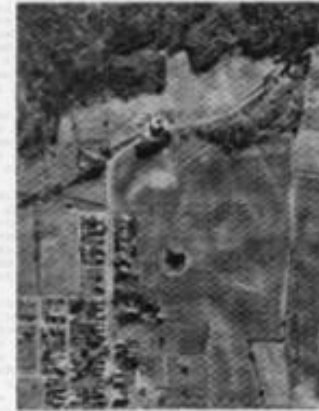
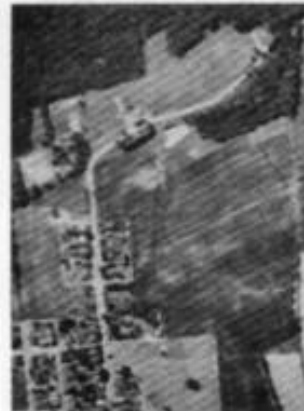
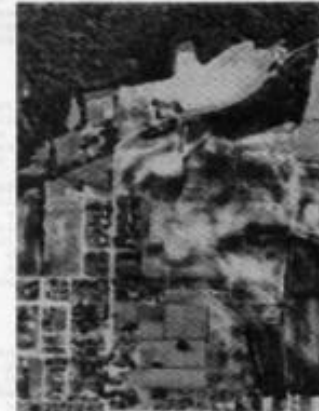
Figure 3: Black and white air photos of Macungie Sinkhole area.

1947 AIRPHOTO - SOIL CONSERVATION SERVICE
PENNSYLVANIA GEOLOGIC SURVEY

1958 AIRPHOTO - SOIL CONSERVATION SERVICE
PENNSYLVANIA GEOLOGIC SURVEY

1964 AIRPHOTO - SOIL CONSERVATION SERVICE
PENNSYLVANIA GEOLOGIC SURVEY

1971 AIRPHOTO - SOIL CONSERVATION SERVICE
PENNSYLVANIA GEOLOGIC SURVEY

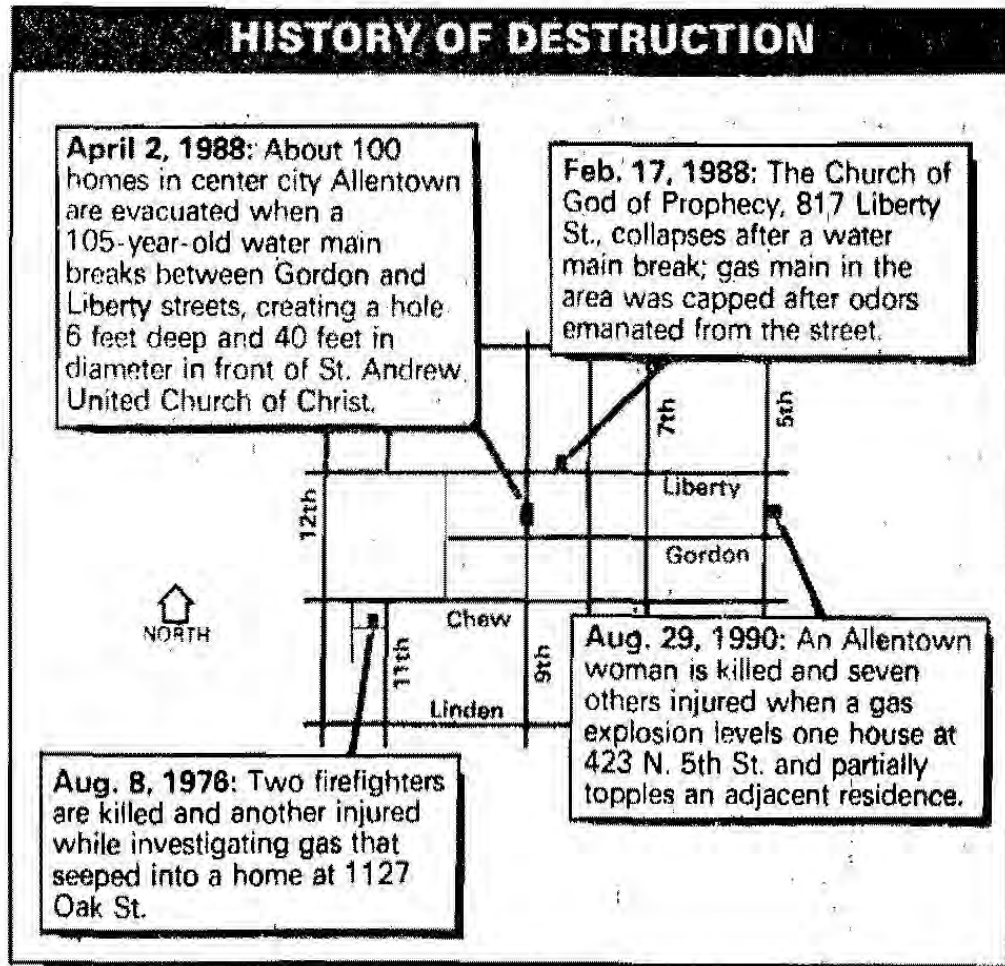
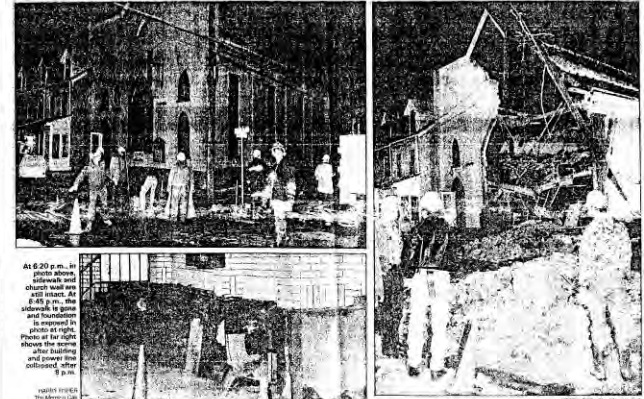
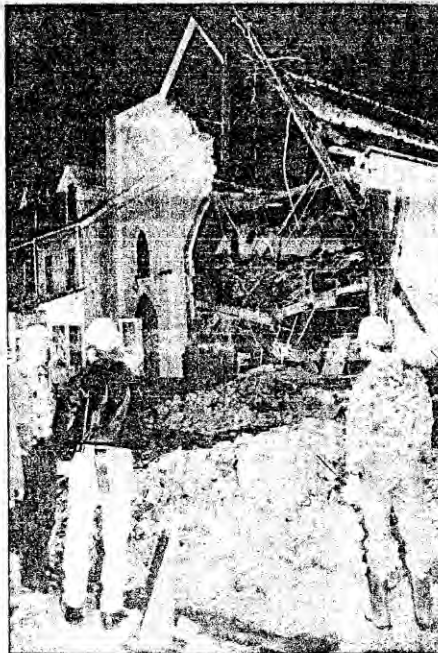
ALLENTOWN – 1976 TO 1990

The collapse occurred at about 10:30 a.m. The church was a two-story building. The ground in front of the church was unstable due to a water main break. The water main was 105 years old and had been replaced in 1976.

The collapse caused a large sinkhole to form in front of the church. The sinkhole was about 40 feet in diameter and 6 feet deep. The church building collapsed into the sinkhole, leaving a large pile of rubble.

Keyser said preliminary indications are that the problem was caused by a 6-inch water main that fractured near Liberty and Myrtle streets, causing a huge sinkhole to

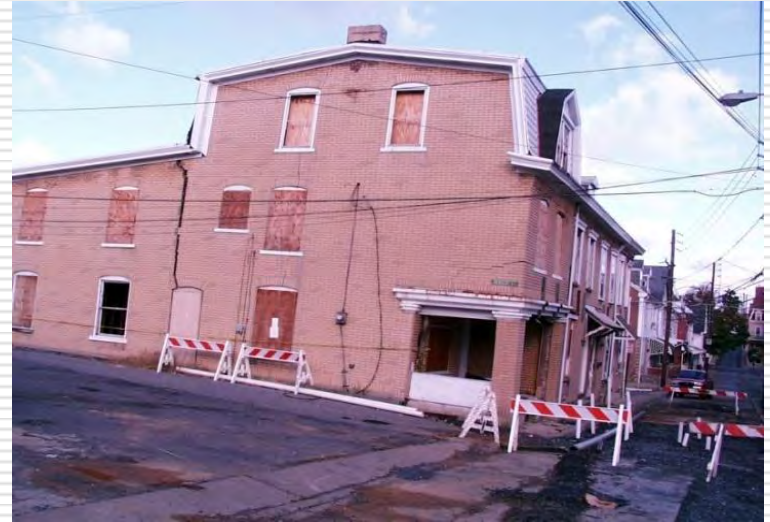
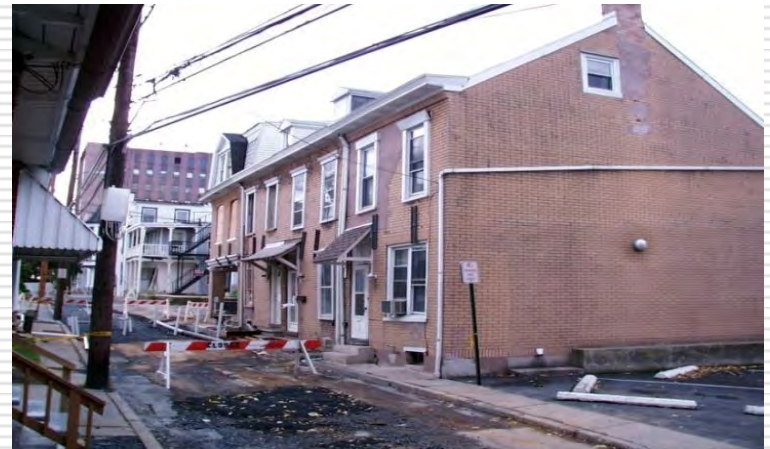
NORTH PENN STREET ALLENTOWN

N. Penn St. in Allentown is cracked after a sinkhole opened up early Tuesday. Right, city Water Resources employees work on the sinkhole. Eleven homes were evacuated about 3 a.m. Residents were allowed to go back later to get their belongings.

Several residents of the 100 block of N. Penn Street were scrambling Tuesday afternoon to retrieve belongings from their homes after the sinkhole left walls cracked and floors uneven.

Code enforcement inspector Tom Rizzotto said Tuesday evening that four homes on the west side of Penn Street were damaged, two of which will likely need to be demolished.

Stalitz said workers found that a century-old water main that the city is replacing had cracked. The old pipe was still in partial use because a handful of properties in the area had not been transferred to the new main, he said.

Stalitz said workers couldn't tell whether the sinkhole caused the pipe to break or vice versa.

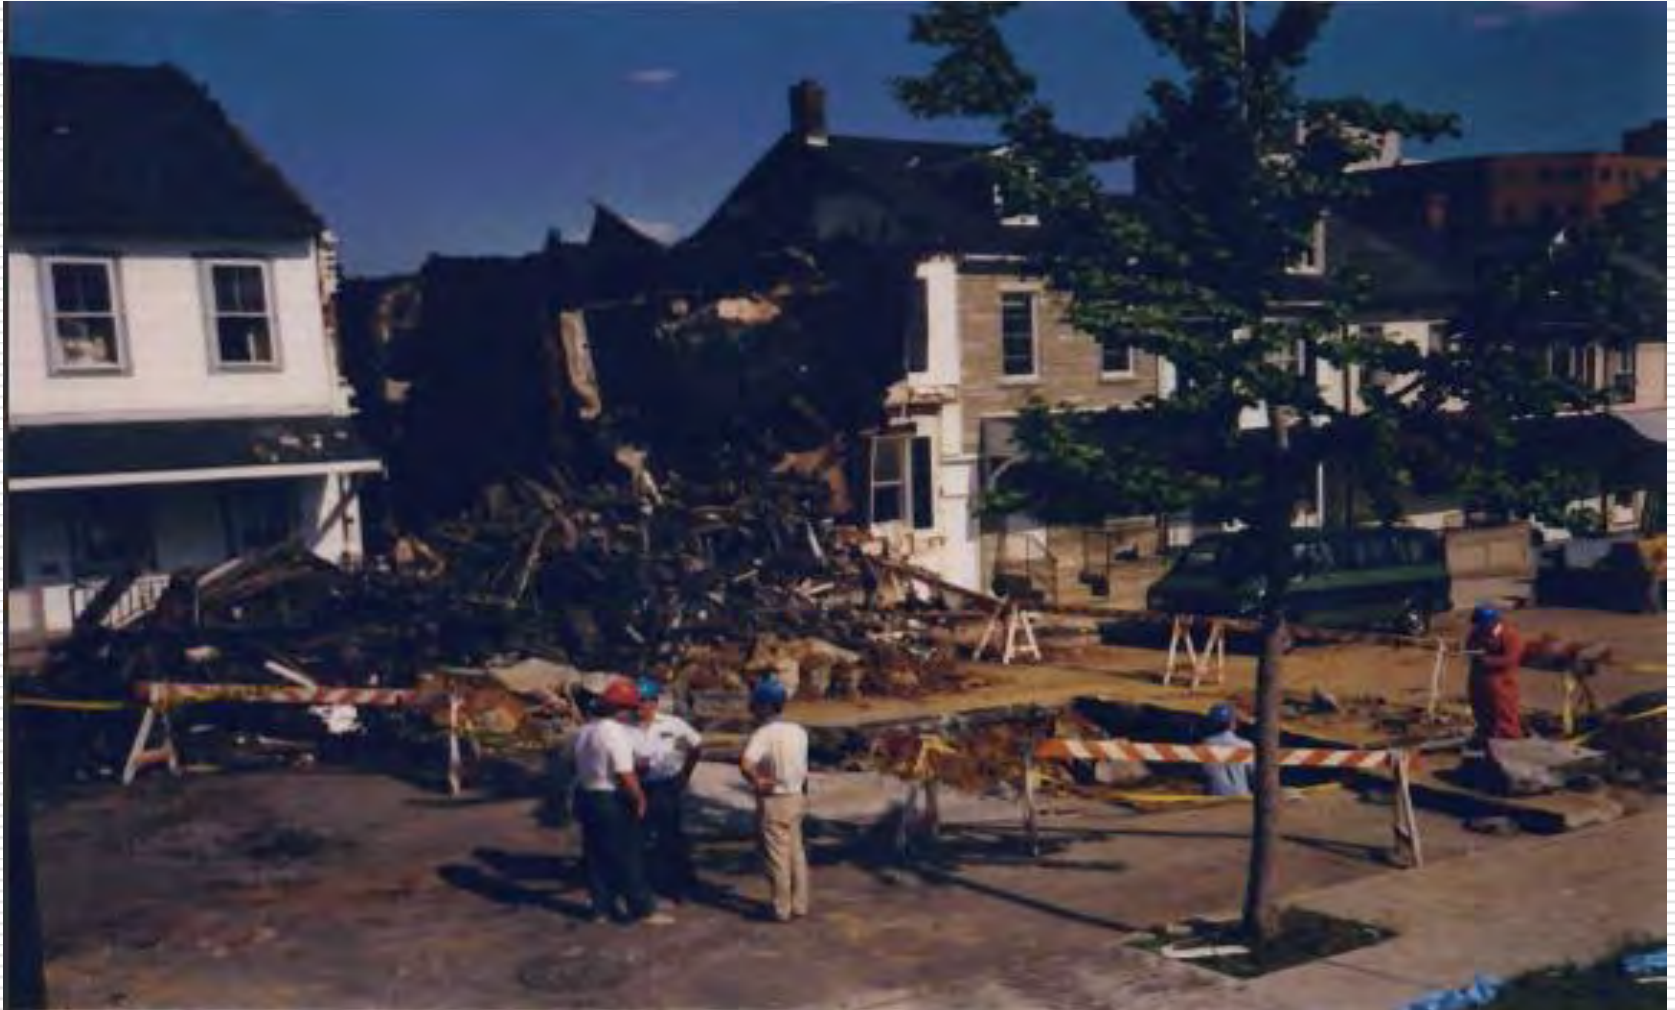
NORTH 5TH STREET - ALLENTOWN

An Allentown fire-fighter hoses down the remains of two homes destroyed in an early morning explosion and fire that killed one person and injured at least seven. The homes are at 423 and 421 N. 5th St.

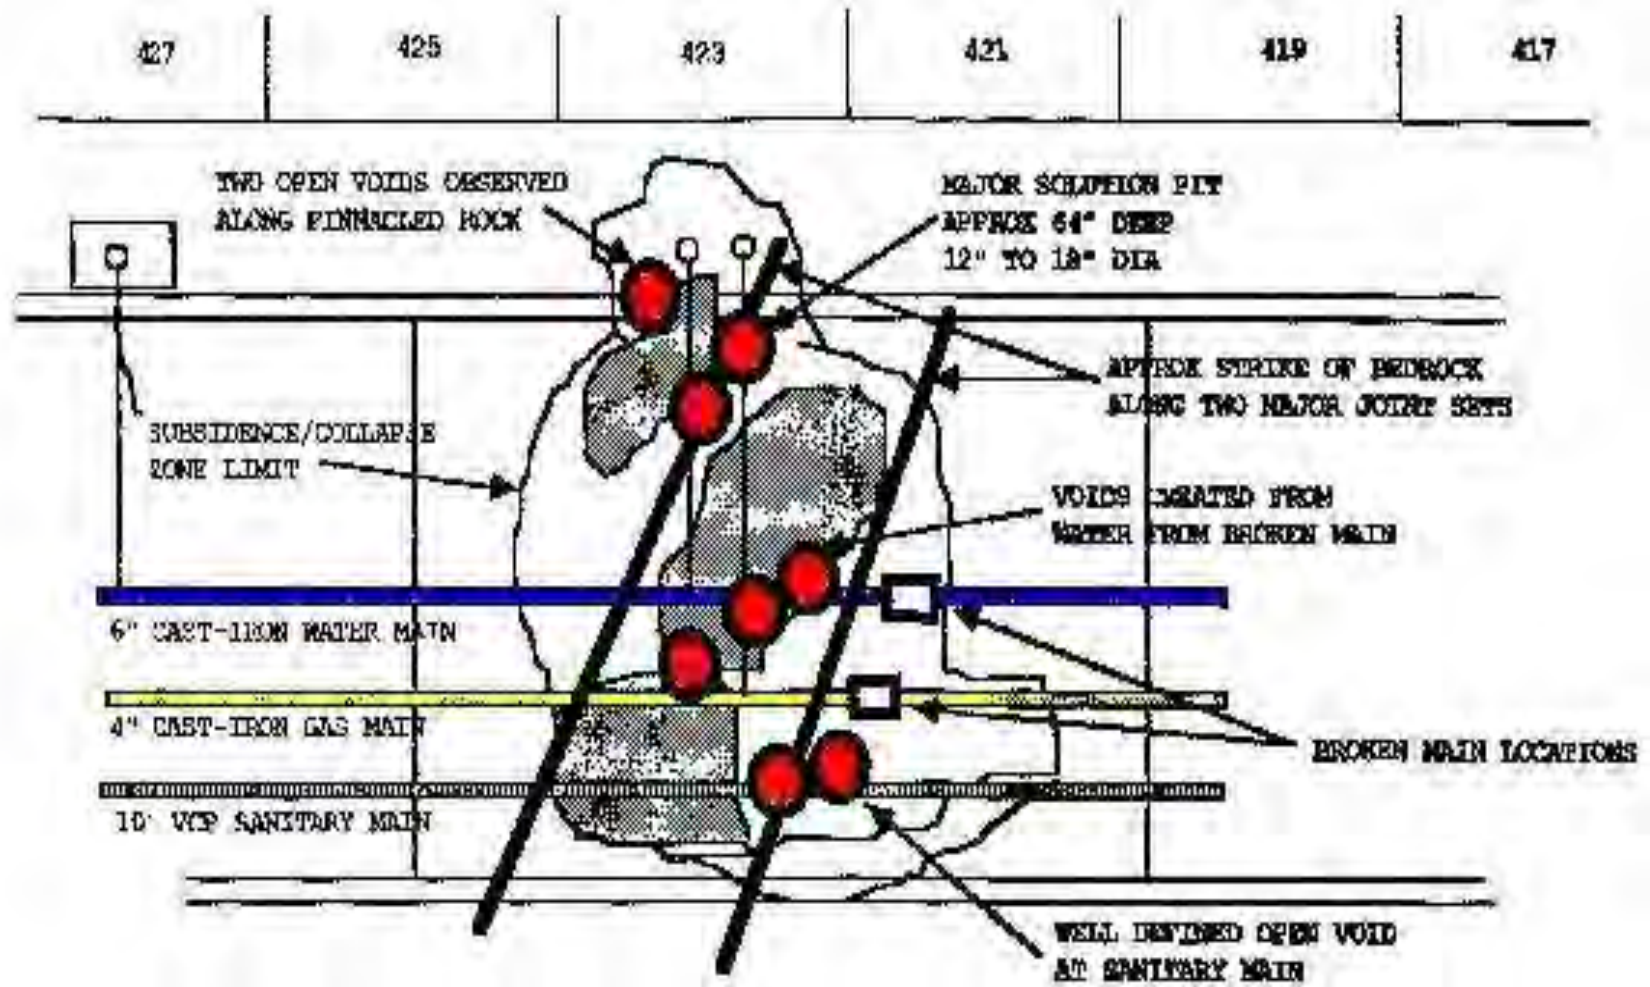
NORTH 5TH STREET - ALLENTOWN

1. HARD/SOFT PAVEMENT SUBGRADE SUPPORT RESULTS IN CRACKING OF CONCRETE PAVEMENT
2. SURFACE WATER BEGINS TO MIGRATE OVER TIME INTO CRACKS SOFTENING RESIDUAL SOILS

3. SLIGHT SUBSIDENCE OCCURS IN SOLUTION ZONES
4. SUBSIDENCE AT LEAD JOINT AT CURB BOX/CORP RESULTS IN LEAK/BREAK OF WATER SERVICES OVER THE PAST 35 YEARS WHICH FURTHER DESTABILIZE SUPPORTING SOILS IN PINNACLED ROCK AREAS

5. WATER SERVICE LEAK OCCURS AT 427 ON 1/28/90 MIGRATING WATER FOLLOWS SIDEWALK/CURB
6. RELEASED WATER ENTERS BEDROCK SOLUTION ZONE RESULTING IN SUBSIDENCE OF SUPPORTING SOILS FOR 425 & 423 GAS/WATER LATERALS

7. FURTHER LEAKS OCCUR IN 423 LATERALS ON 8/29 RESULTING IN A MAJOR LEAK OF GAS AND WATER
8. GAS EXPLOSION OCCURS BREAKING LATERALS/MAIN
9. ONCE WATER MAIN BREAKS, SUBSURFACE EROSION OF SUPPORTING SOILS OCCURS BY ENTRY OF RELEASED WATER INTO UNDERLYING SOIL AND ROCK VOIDS

10. SANITARY MAIN SUBSIDES/GAS MAIN IS BROKEN
11. SUBSURFACE EROSION CONTINUES UNTIL MAIN IS SHUT OFF RESULTING IN MAJOR GROUND LOSS AND SUBSIDENCE

- Conduct a GPR Survey to confirm the location of solution weathered high risk areas
- Replace the water main in the high risk areas

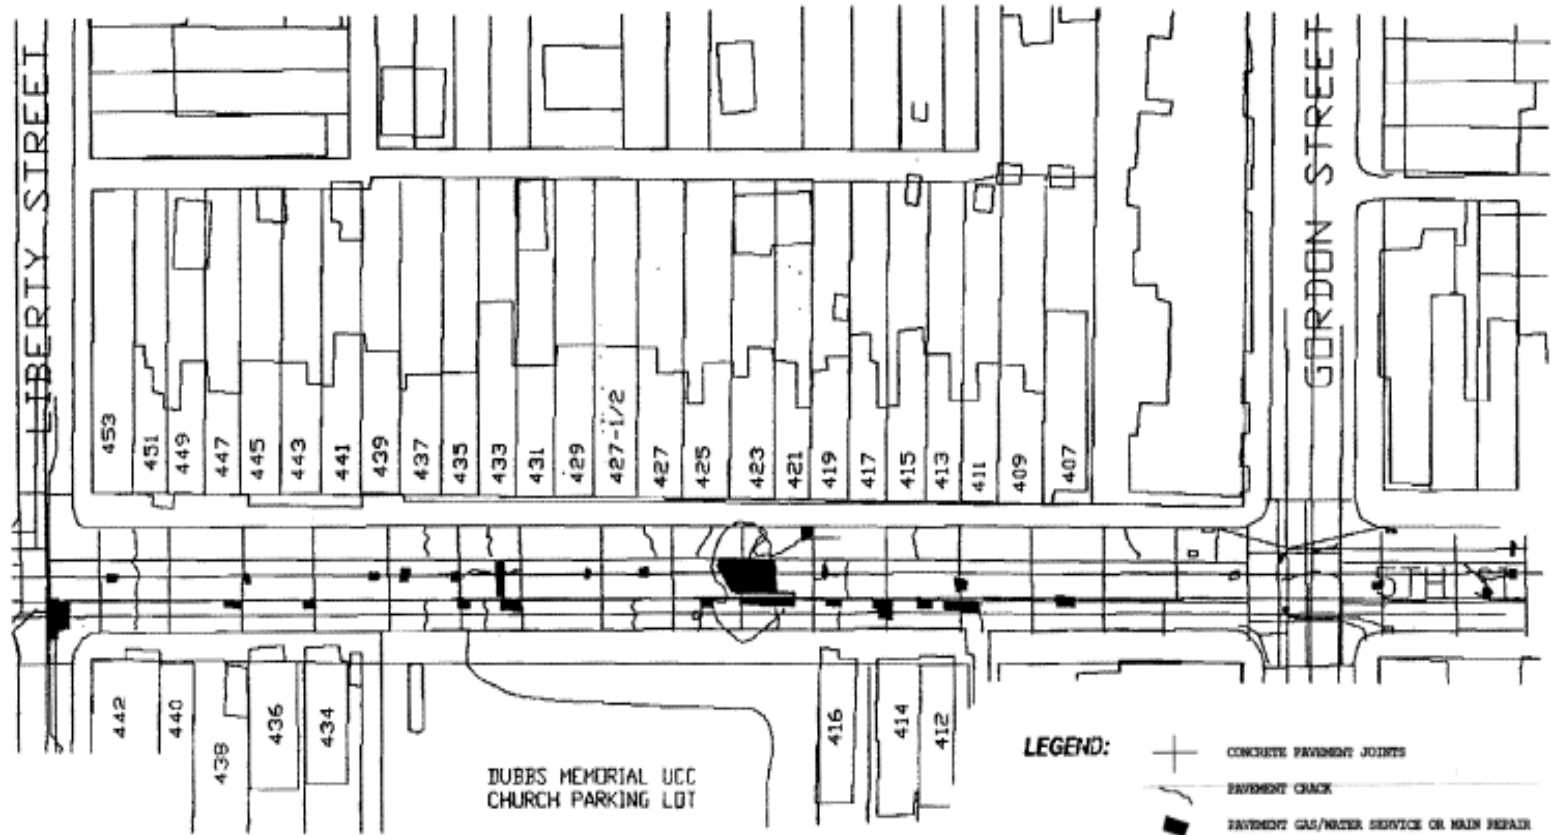
PAVEMENT CRACKING INDICATORS

- Pavement cracking was an early indicator of subsurface erosion and subsidence
- The increasing number of water service leak-break frequency was a secondary warning
- The presence of suspected solution weathering zones identified where a failure could occur
