Creating a New Legacy out of the Past Membrane Retrofit of the Brandywine Filtration Plant

By Roger K. Noack, P.E.

2012 PA Section AWWA Annual Conference

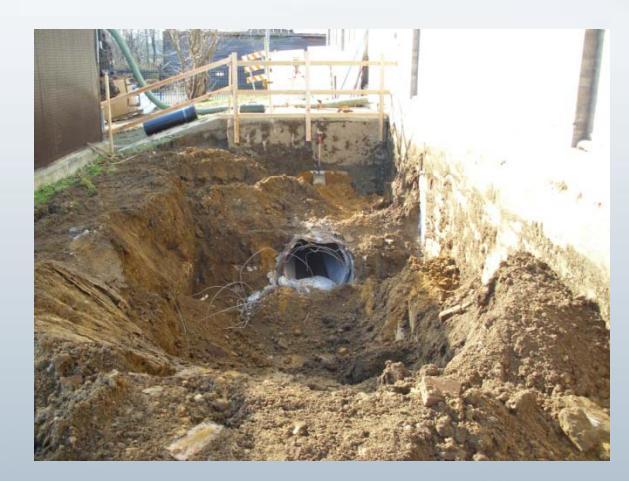
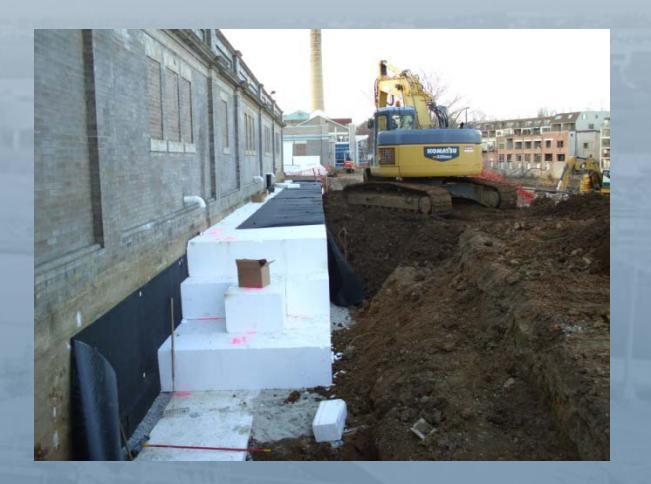
Protection of Existing Structure

- No good drawings of existing structure
- Removed interior support of exterior wall by demolition
- Need to remove exterior loading on the wall to prevent failure
- Geofoam installation

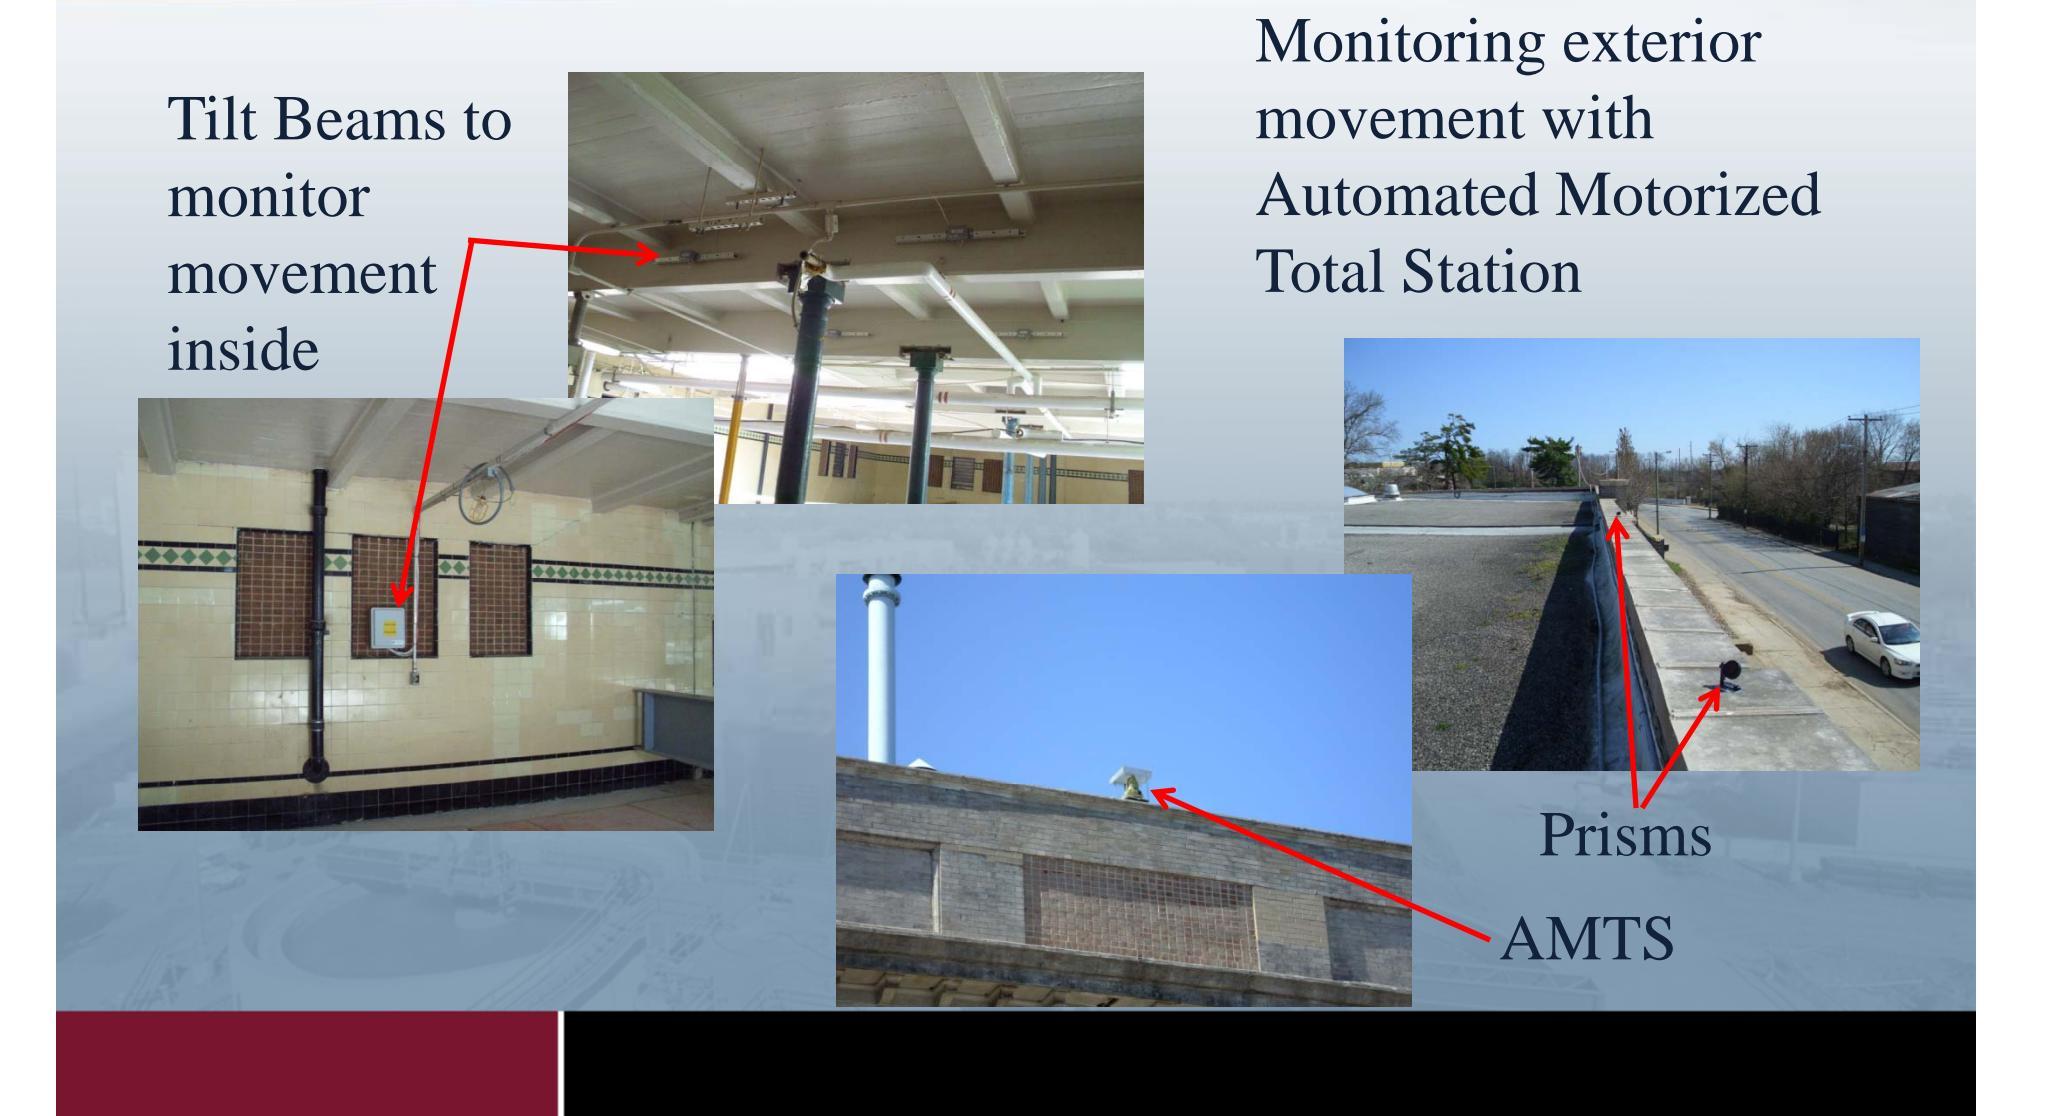
Monitoring of Existing Struture

- Monitor continuously for movement of existing structure
 - Real time
 - Seasonal
 - Daily
- Seismographs for vibration monitoring
- Dynamic strain gauge monitoring for determining of permanent damage
- Tilt beams to monitor movement of roof structure
